### Inspection Report – Structural & Electrical

May 13, 2025

Regarding: Historical Renovation of 1895 Church  
311 SW 3rd St.  
Stuart, FL 34994

Date of Inspection: 04/04/25

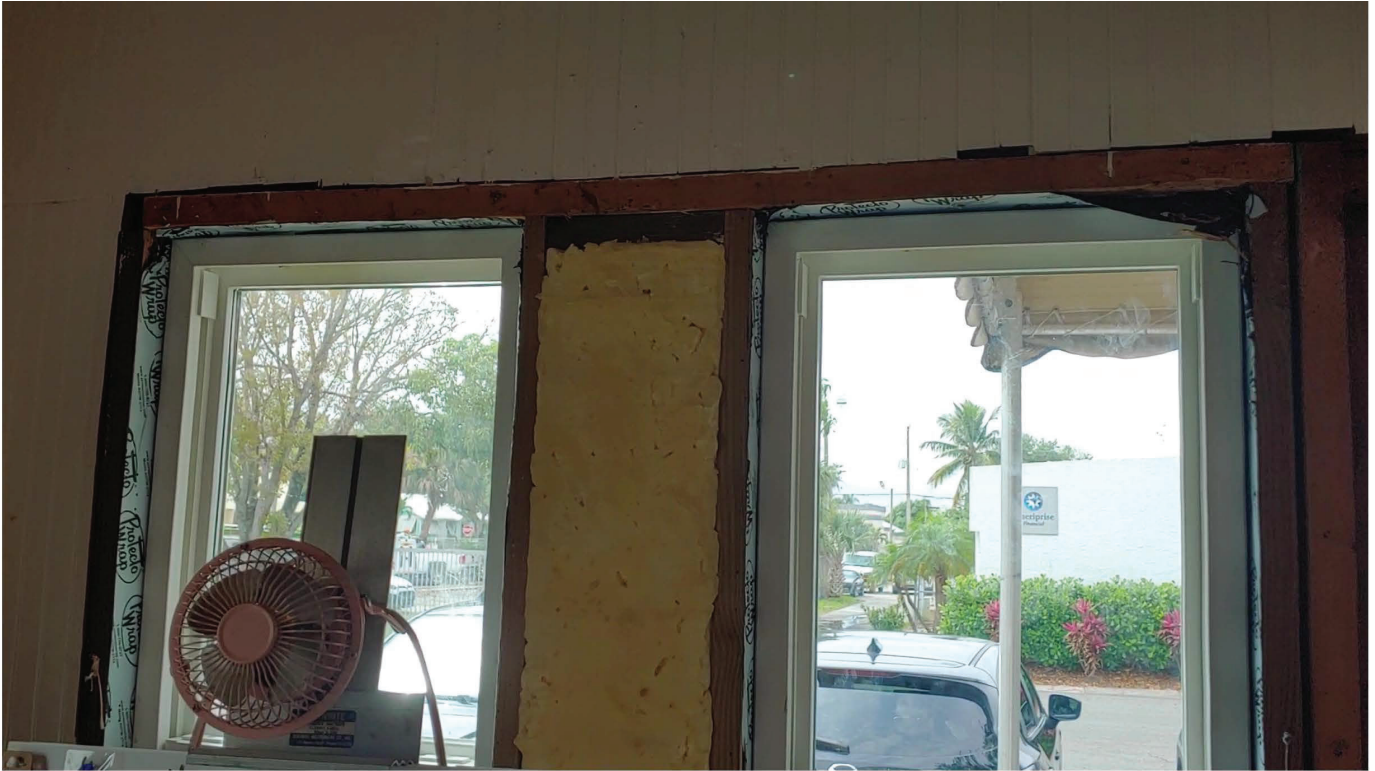
Figure 3 - Opening #1 - Improper Header

Found during the inspection and documented in this report as “improper header” the headers above these windows lie horizontally. This does not mean that there is absolutely a structural issue. If there is sufficient framing to carry the load around the window in a continuous path such that the window will not carry any of the loading from above it, the structure is most likely safe and stable. Where the window is considered to be carrying load, that condition needs to be corrected to prevent the window from being damaged or failing to operate properly. Since these walls were not fully opened it is not possible to make the determination at this time.

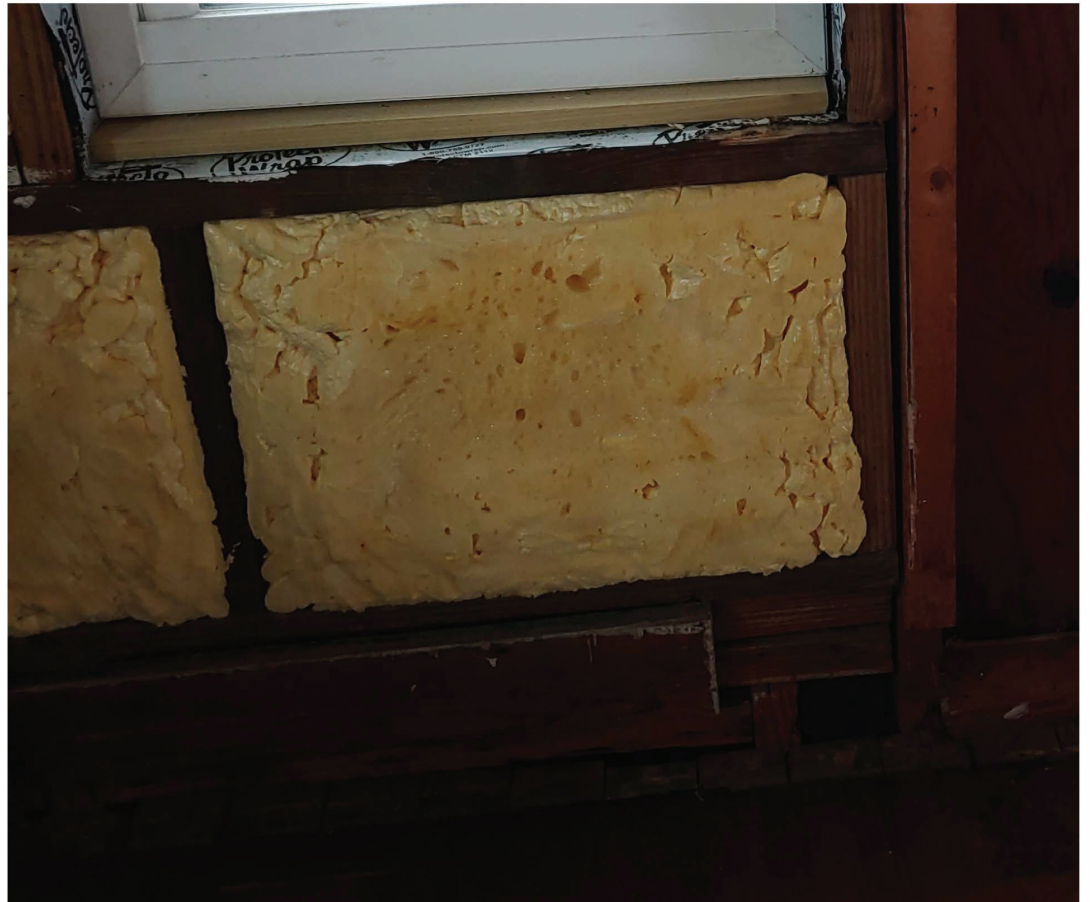
Trimmer missing on right and left – See Figure 4

Figure 4 - Opening #1 - Right Side Load Path somewhat there.

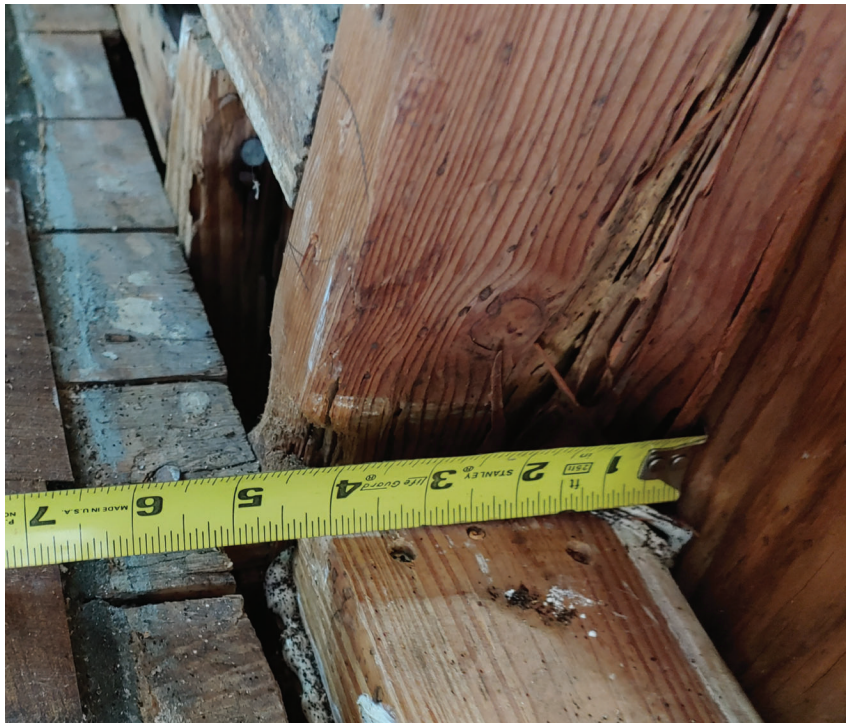
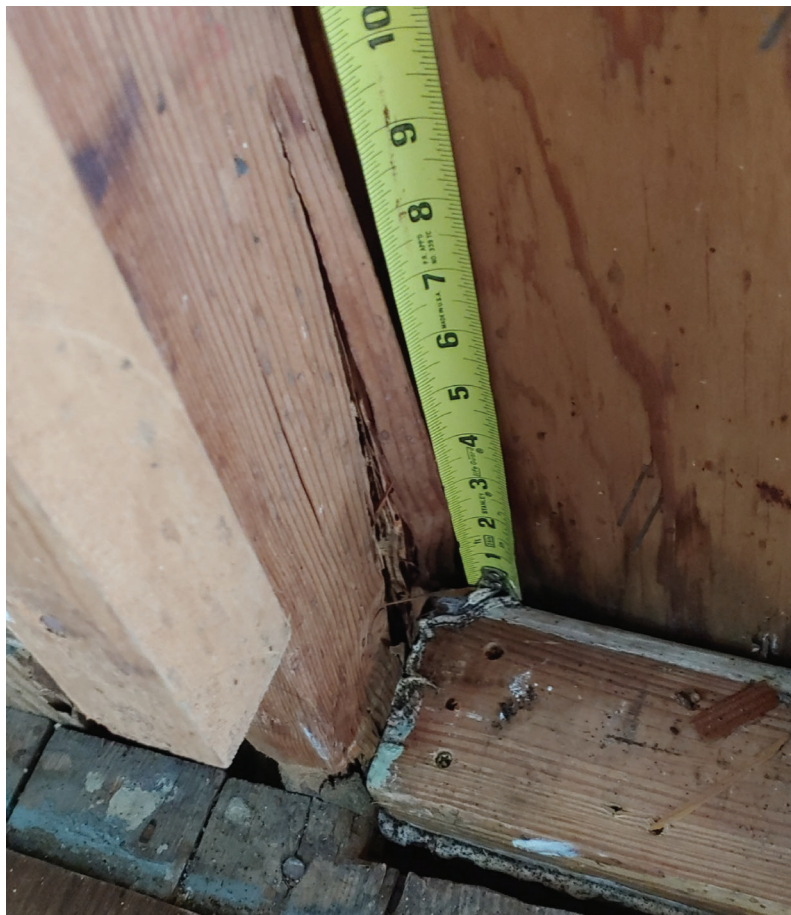
Rot at bottom (Area = 2"x ~10") – See Figures 5 & 6

Figure 5 - Opening #1 - Rot at Bottom connection

Figure 6 - Opening #1 - Rot at Bottom connection

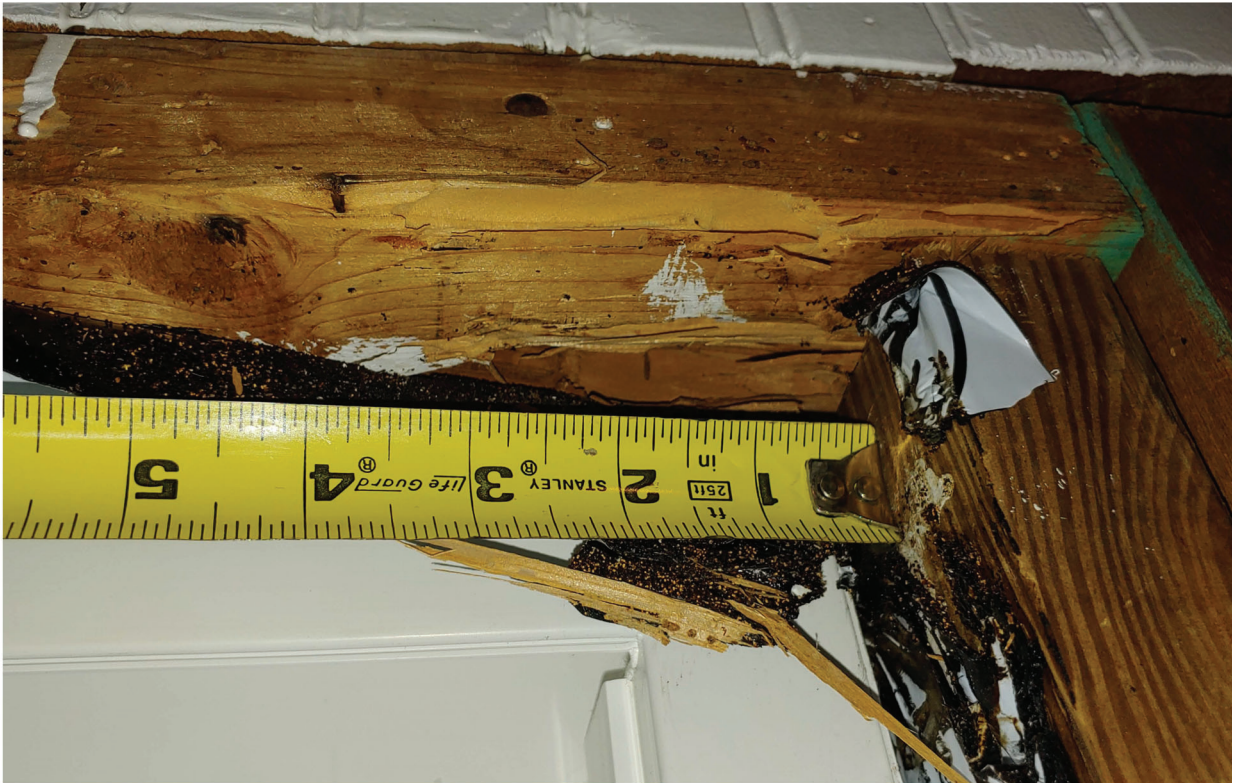
Rot at Top (3"x ~4") – See Figure 7

Figure 7 - Opening #1 - Rot at Top connection

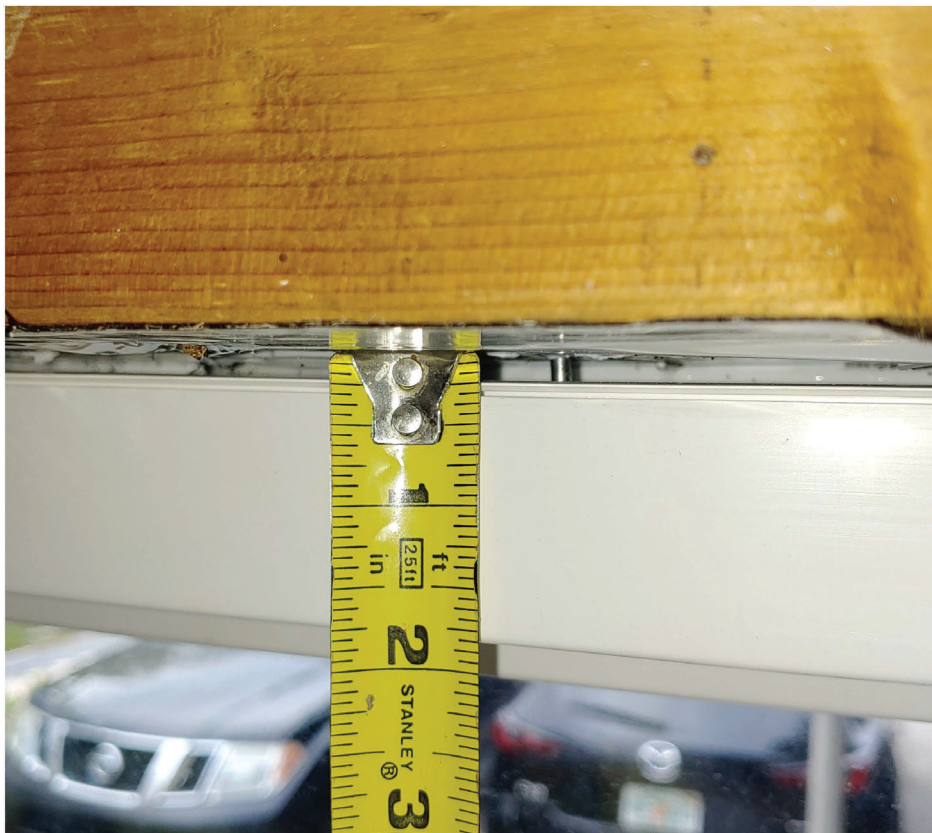
Shim Gap and missing shims – See Figure 8

Figure 8 - Opening #1 - Shims are missing in several places, shim gap is excessive.

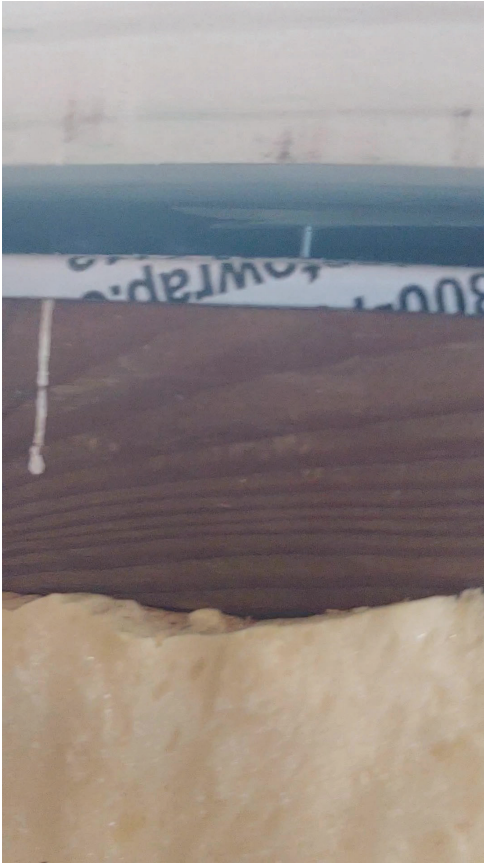
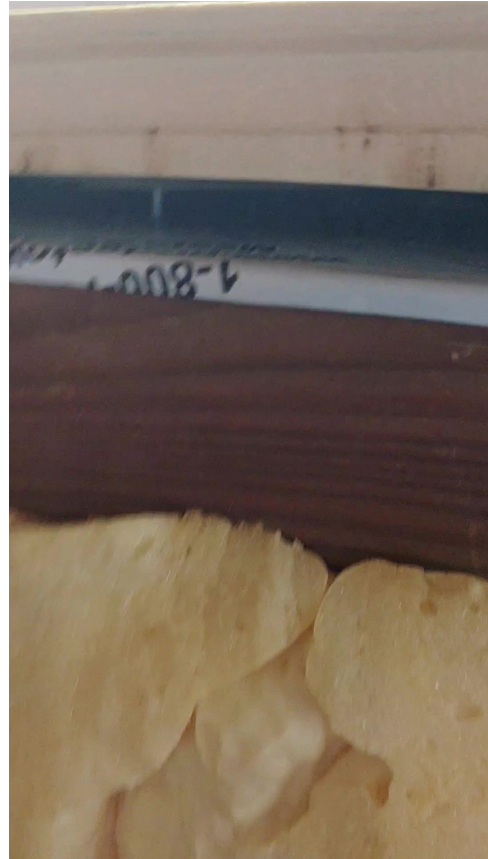
Figures 9 & 10 - Opening #2 - Sill not Installed or shimmed properly

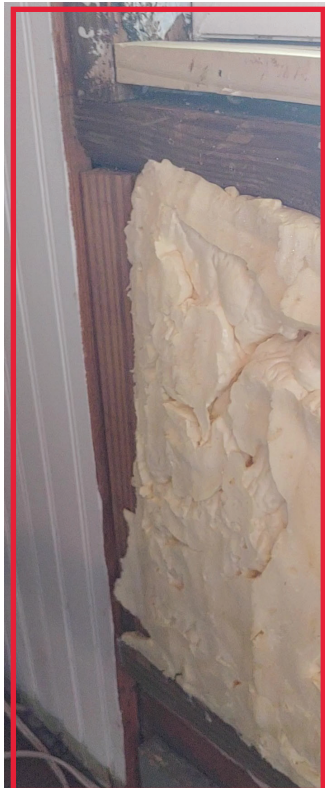
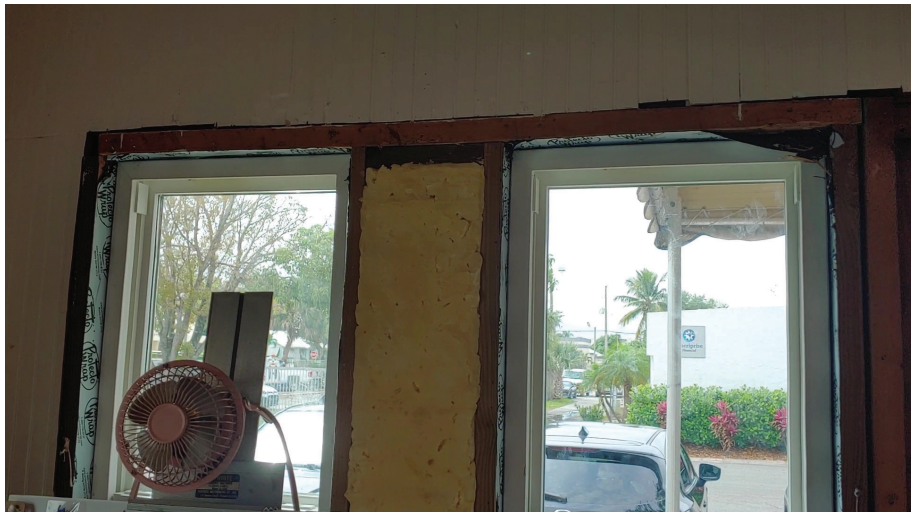
Figures 11 & 12 - Opening #2 - Header and Trimmer on Left Side are not properly installed.

Header not proper – See Figures 11 & 12

Trimmer missing on Left and right – See Figure 11

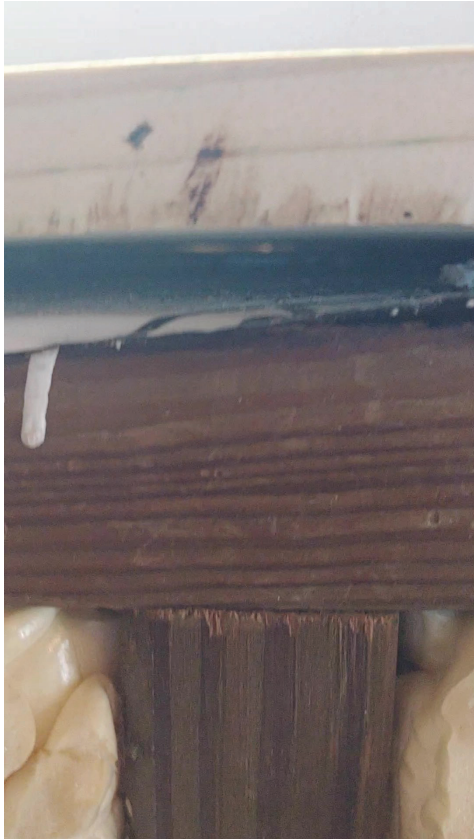
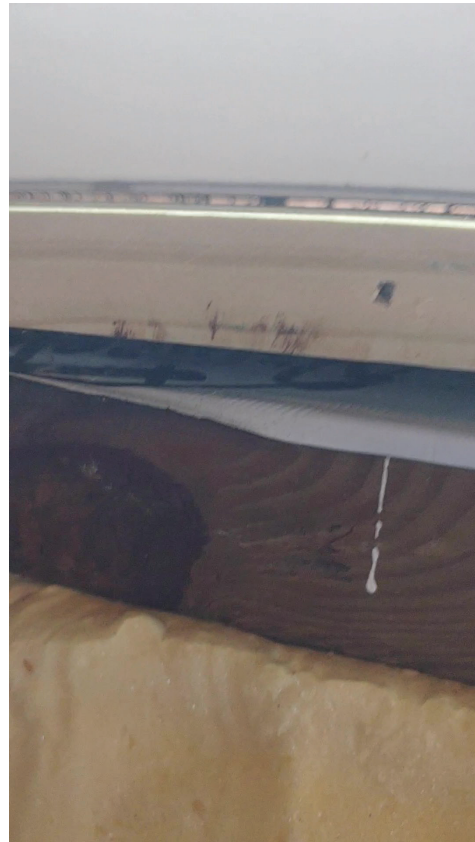
Figures 13 & 14 - Opening #2 - Sill not Installed, shimmed or sealed properly

Sill is not sealed, light shines through – See Figures 13 & 14

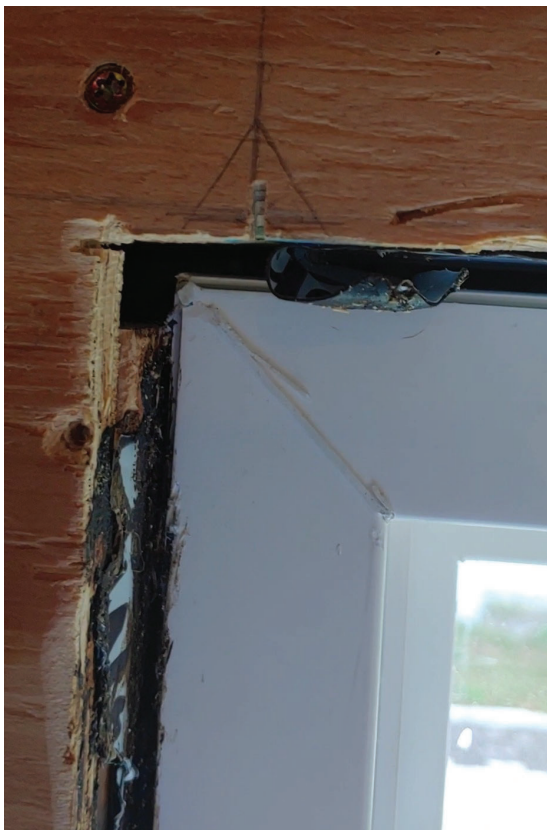
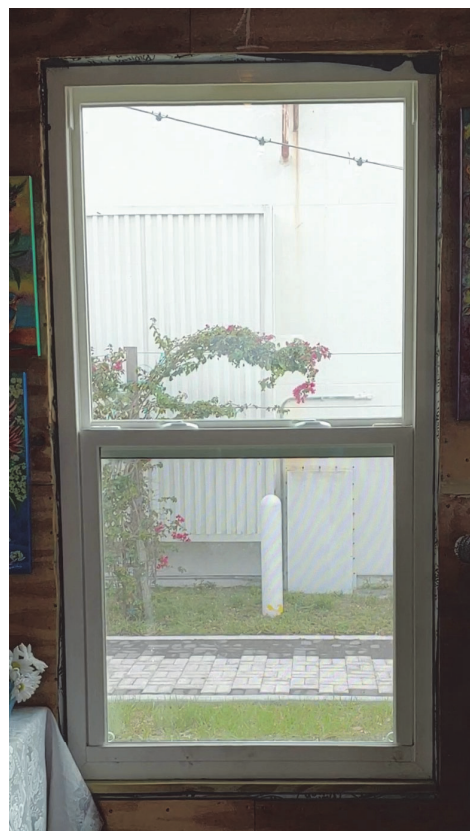
Figures 15 & 16 - Opening #3 - Structural is obstructed, Excessive Shim Gap

Shim Gap at top, bottom and left side - missing shims – See Figures 15 & 18

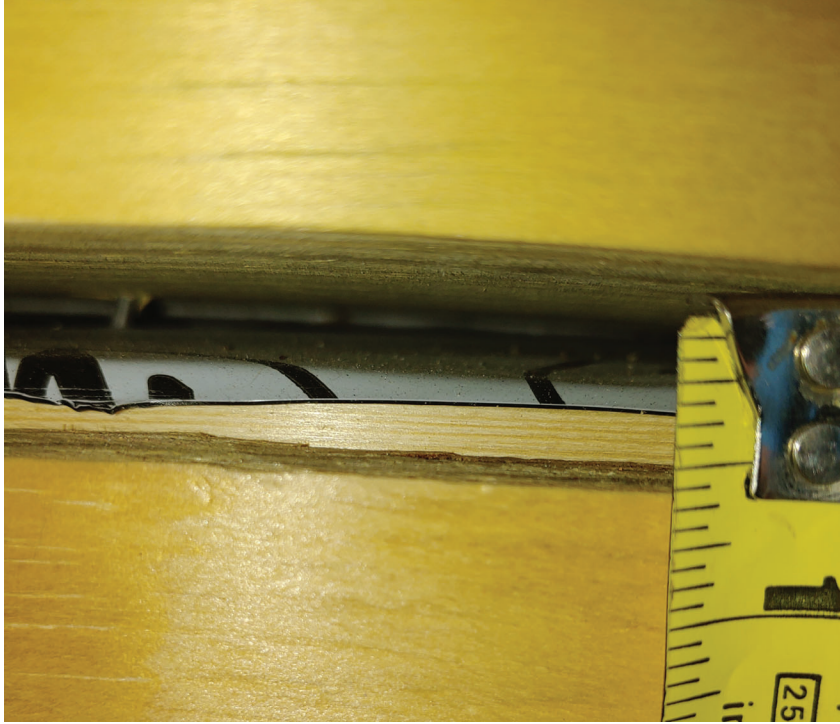
Figure 17 - Opening #3 - Sill Installation missing shim  
Excessive shim gap

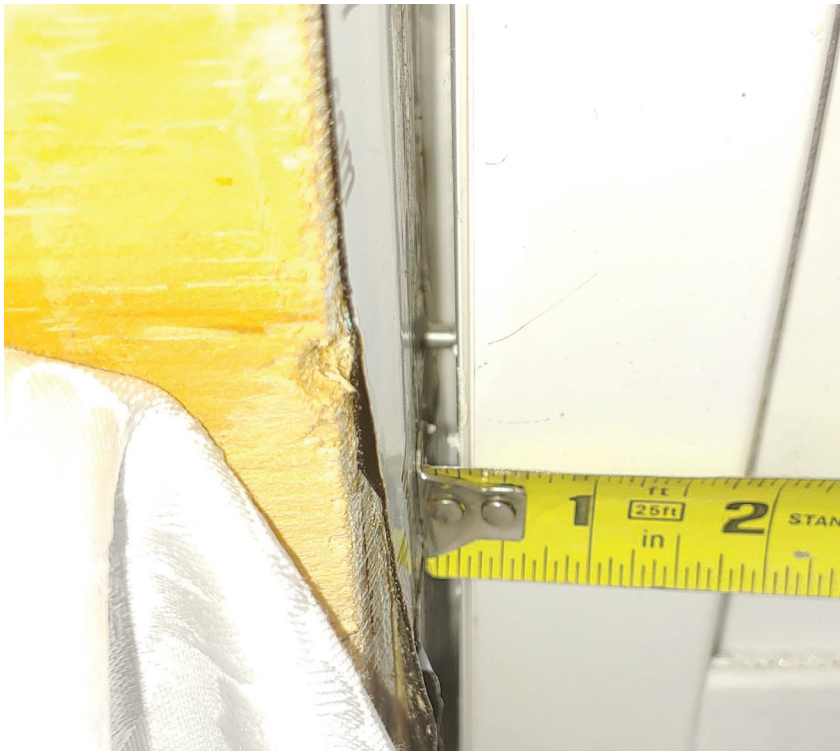
Figure 18 - Opening #3 - Missing shim Excessive  
shim gap

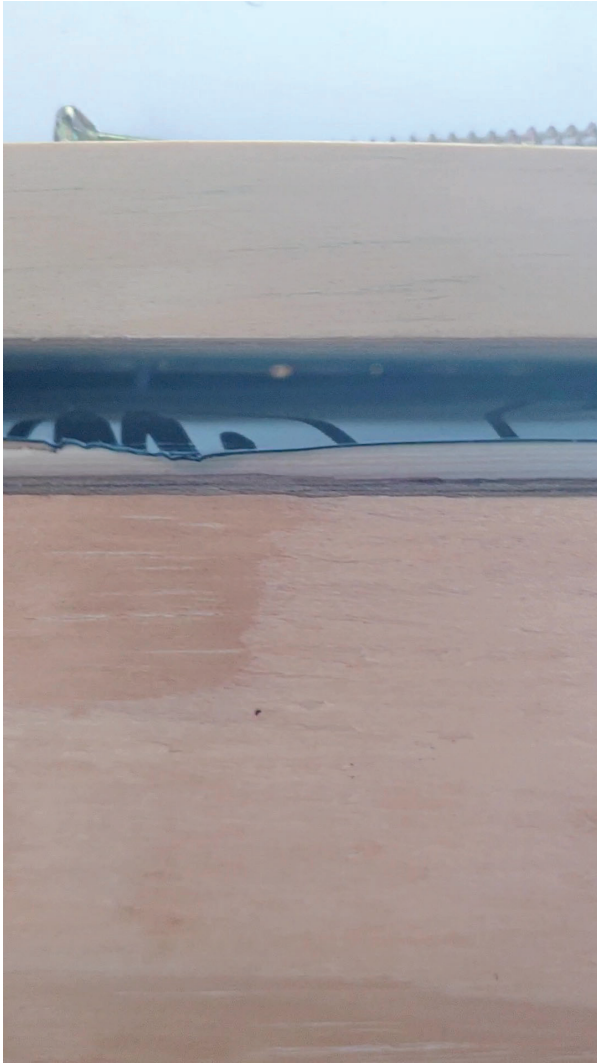
Figure 19 - Opening #3  
- Missing shim, Insufficient sealant

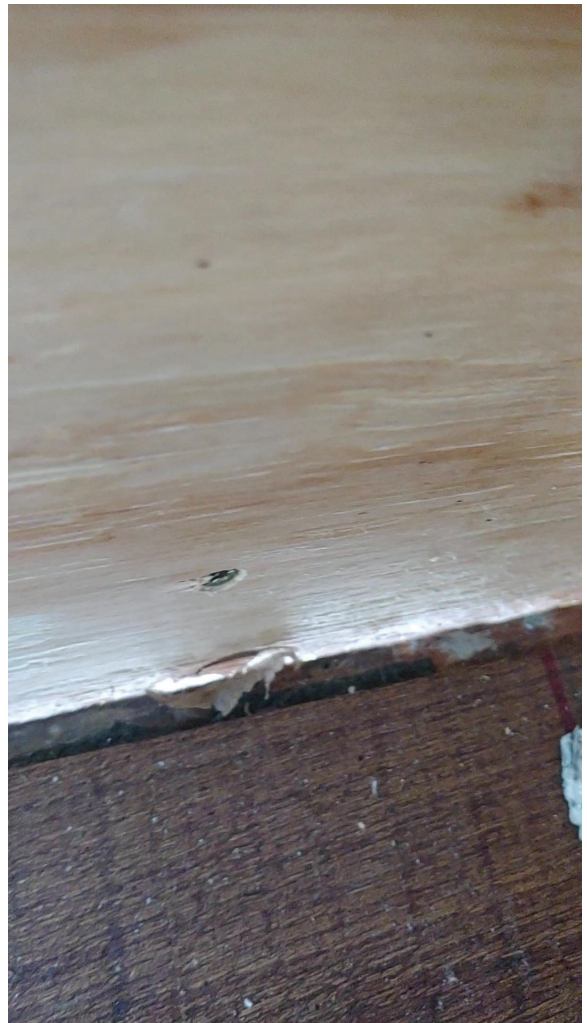
Figure 20 - Opening #3  
- Missing shim, Excessive shim gap

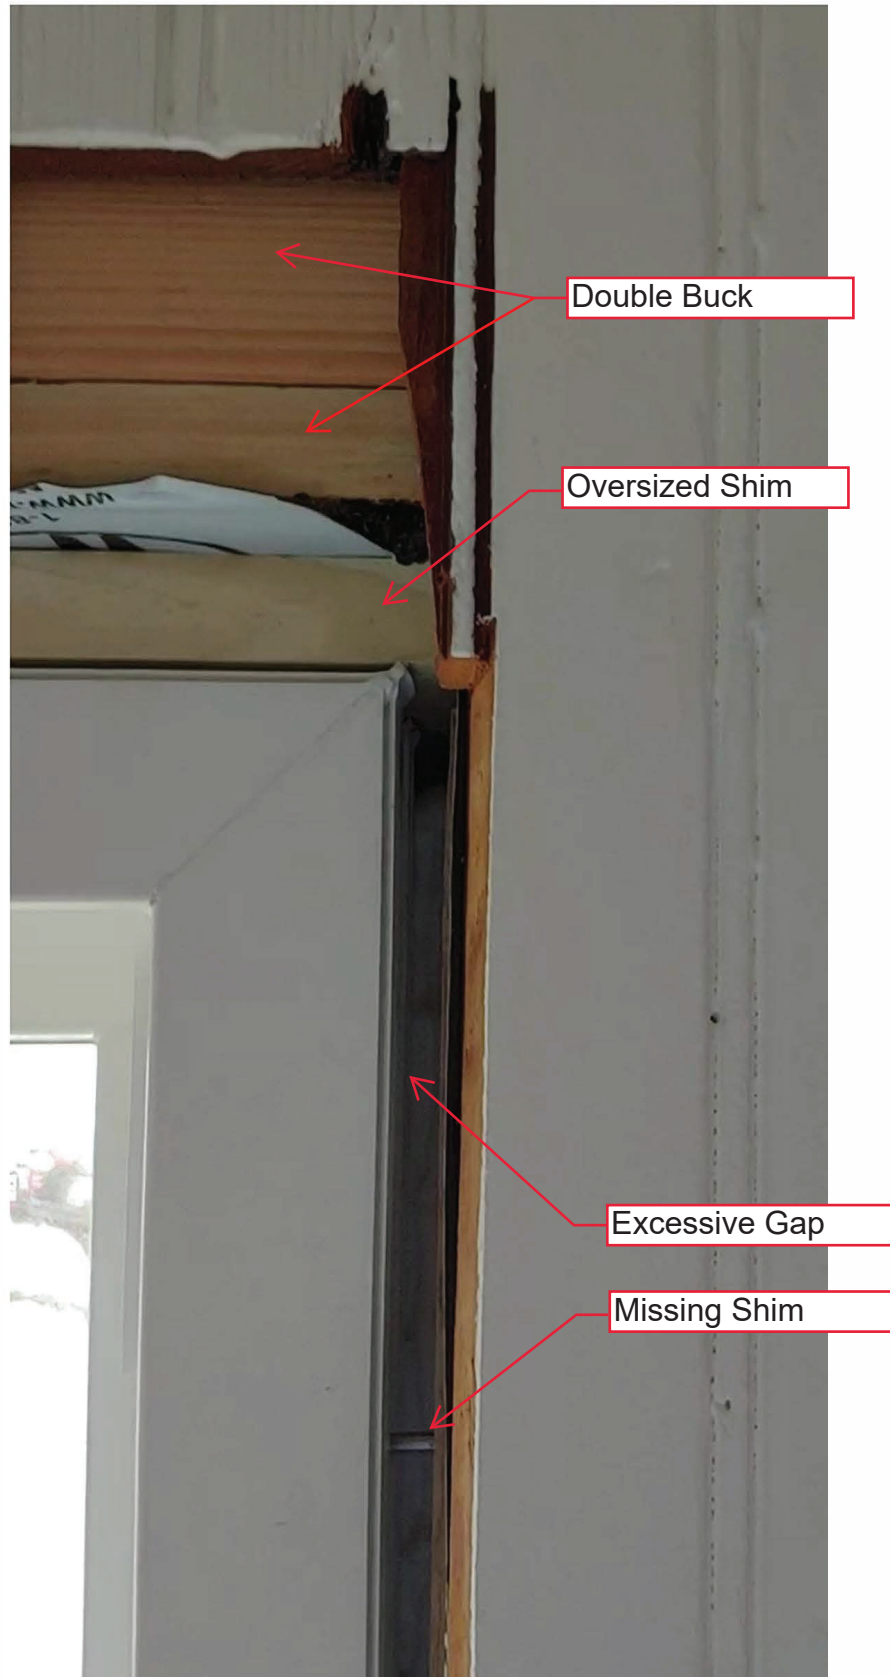
Excessive gaps, missing shims – See Figure 21

Figure 21 - Opening #4 - Double Buck with Oversized Shim at Header; Missing Shim, Excessive Shim Gap

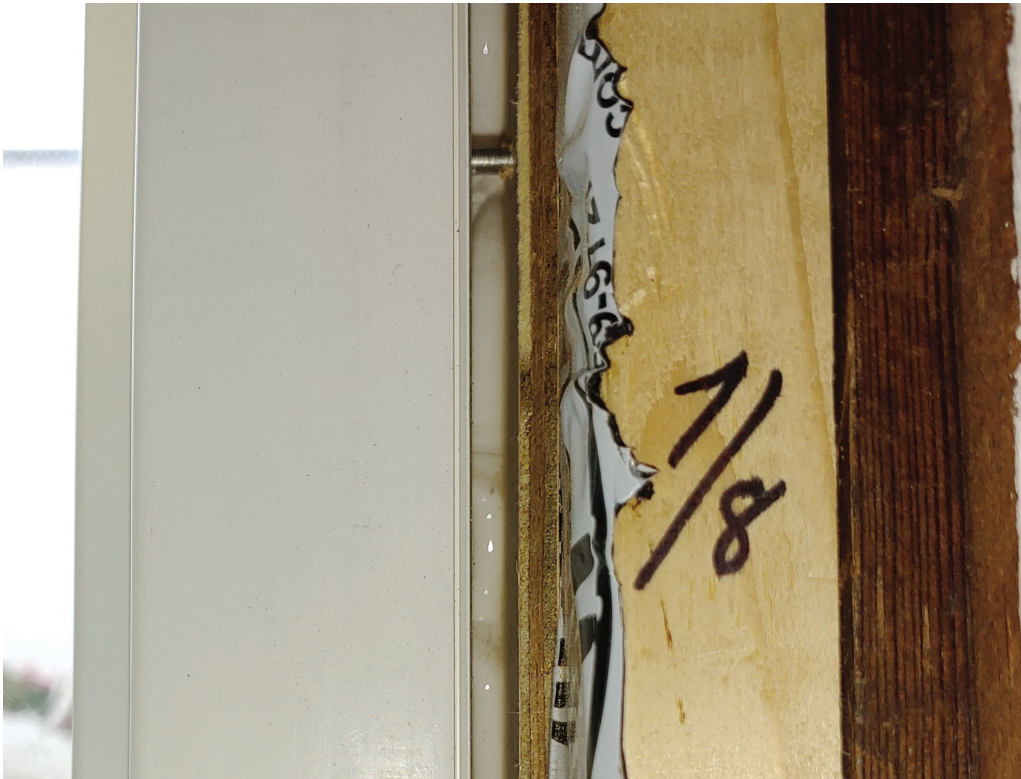
Shim Gap at sides and bottom - missing shims – See Figure 22

Figure 22 - Opening #4 - Double Buck with over sized Shim; missing shim  
Excessive shim gap

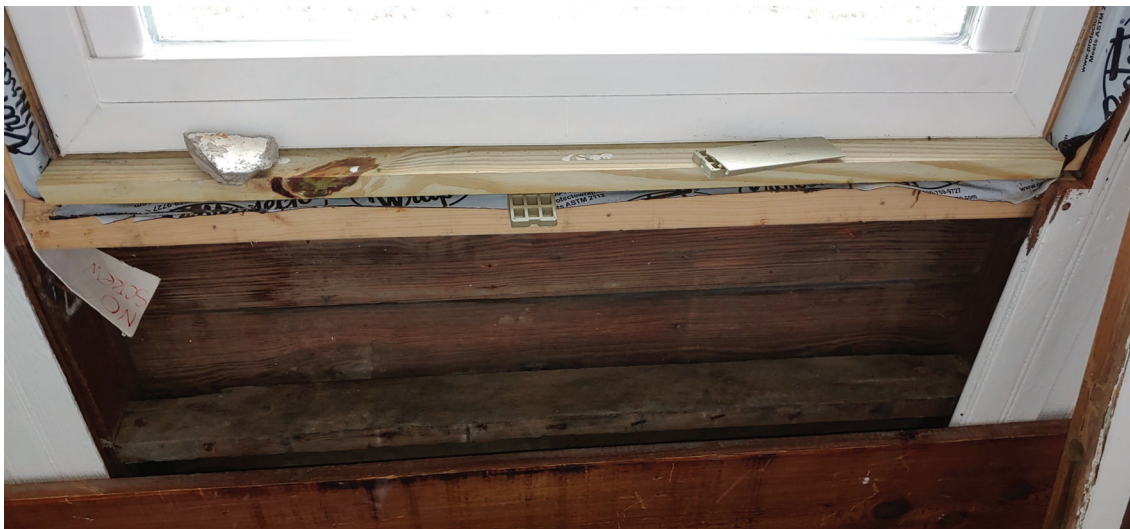
The Opening is missing Jack Studs (34" span) – See Figure 23

Figure 23 - Opening #4 - Missing Jack Studs to support Sill;  
No Functioning Trimmer Studs

Where missing, the Sole or Bottom Plate should be restored to its original condition with connections to the adjacent structural members and wall framing above. Trimmers and properly oriented headers should be installed with Cripples and Jack studs used where appropriate.

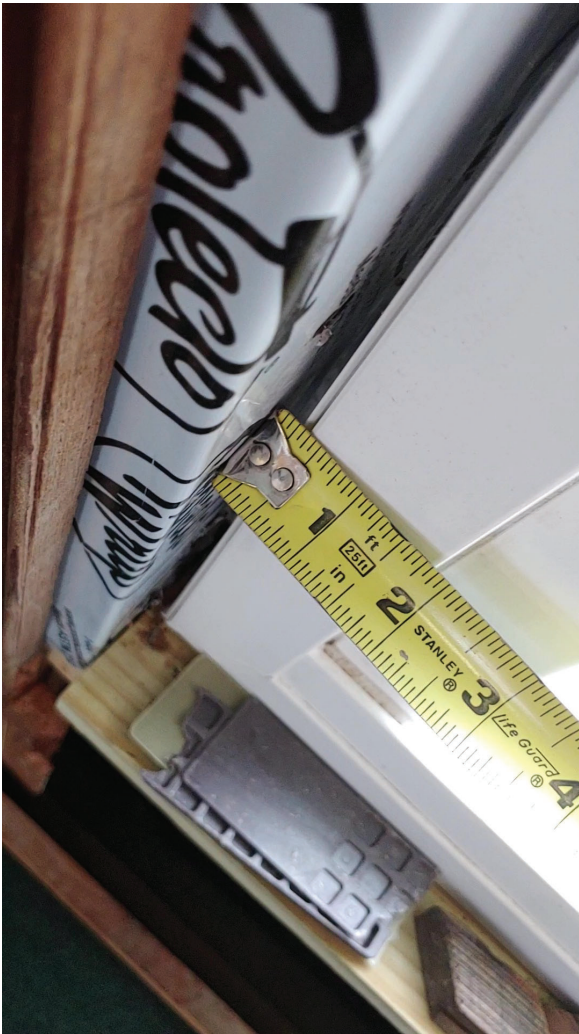
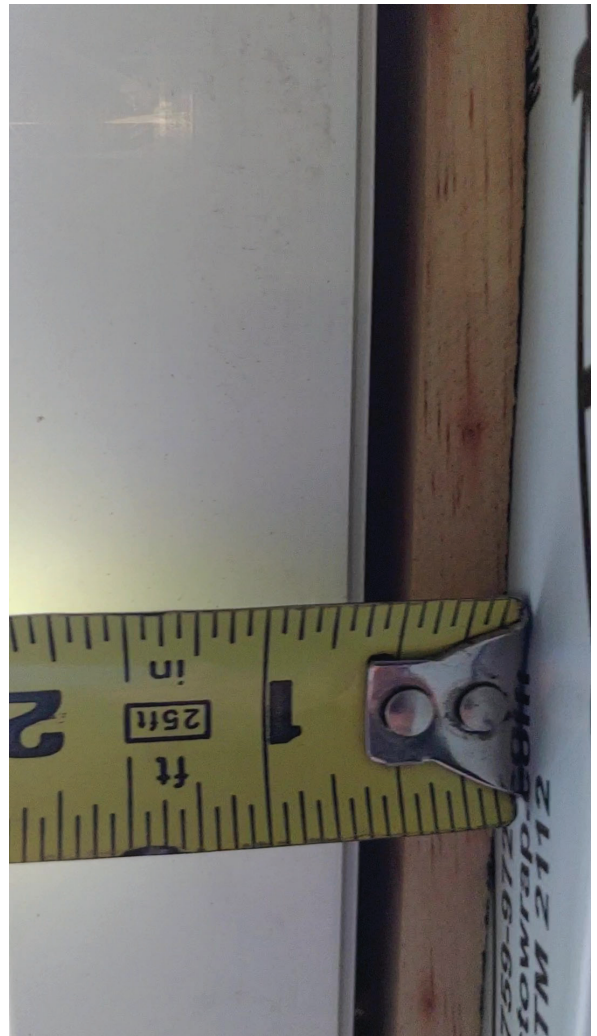
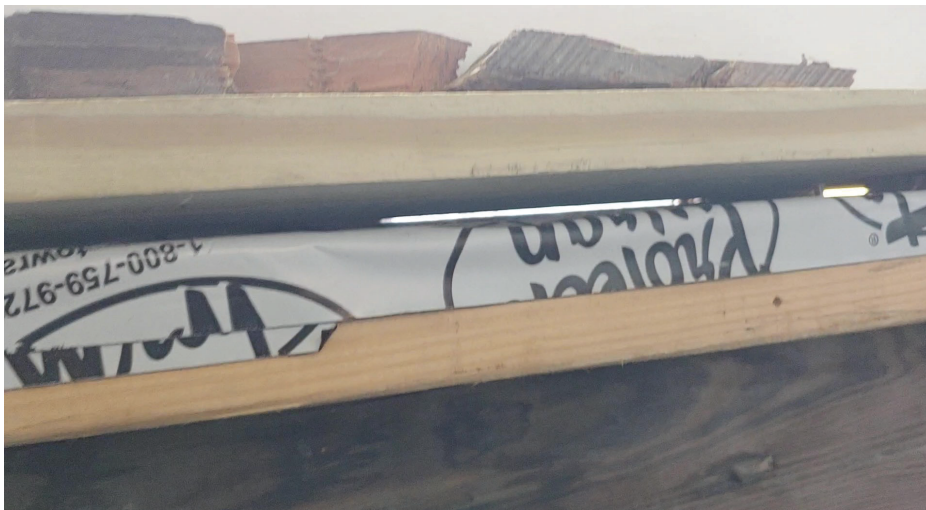
Excessive gaps, Missing shims at sides and Sill – Figures 24 – 26

Figures 24 & 25 - Opening #5 - Oversized Shim; Missing Shim  
Excessive Shim Gaps

Figure 26 - Opening #5 - Improper Sill Installation  
Missing Shims  
Excessive Shim Gaps

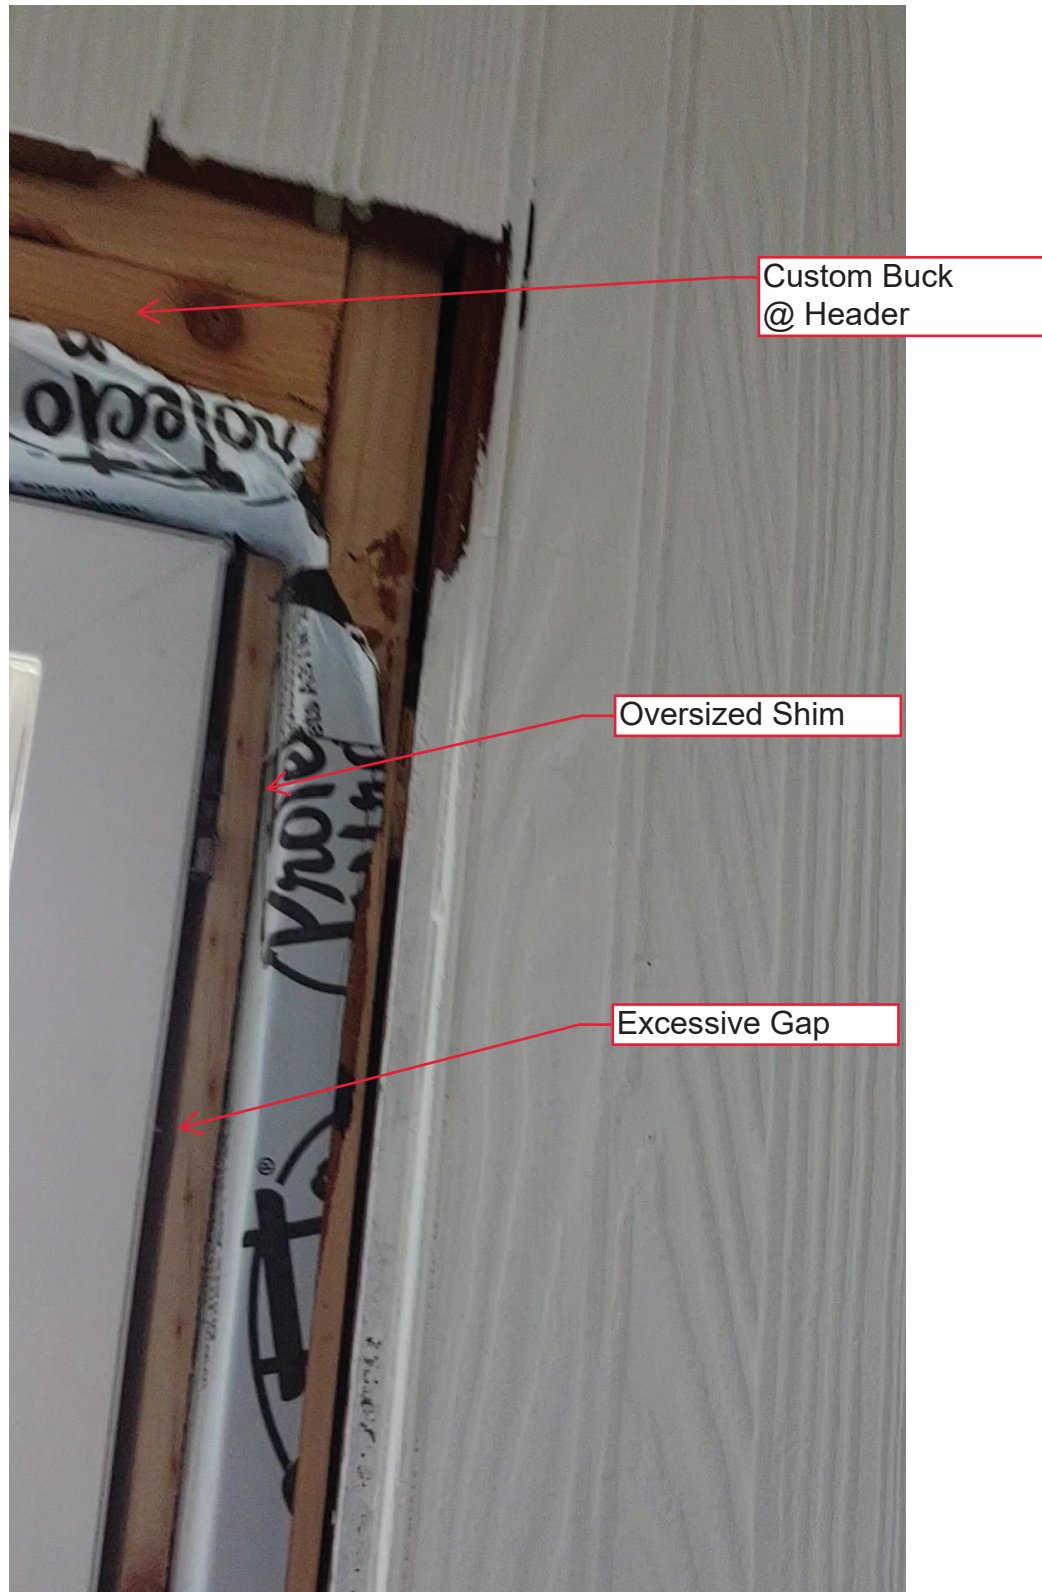
Shim Gap at sides and bottom - missing shims – See Figures 27 & 28

Figure 27 - Opening #5 -Custom Buck Installation  
Missing Shims  
Excessive Shim Gaps

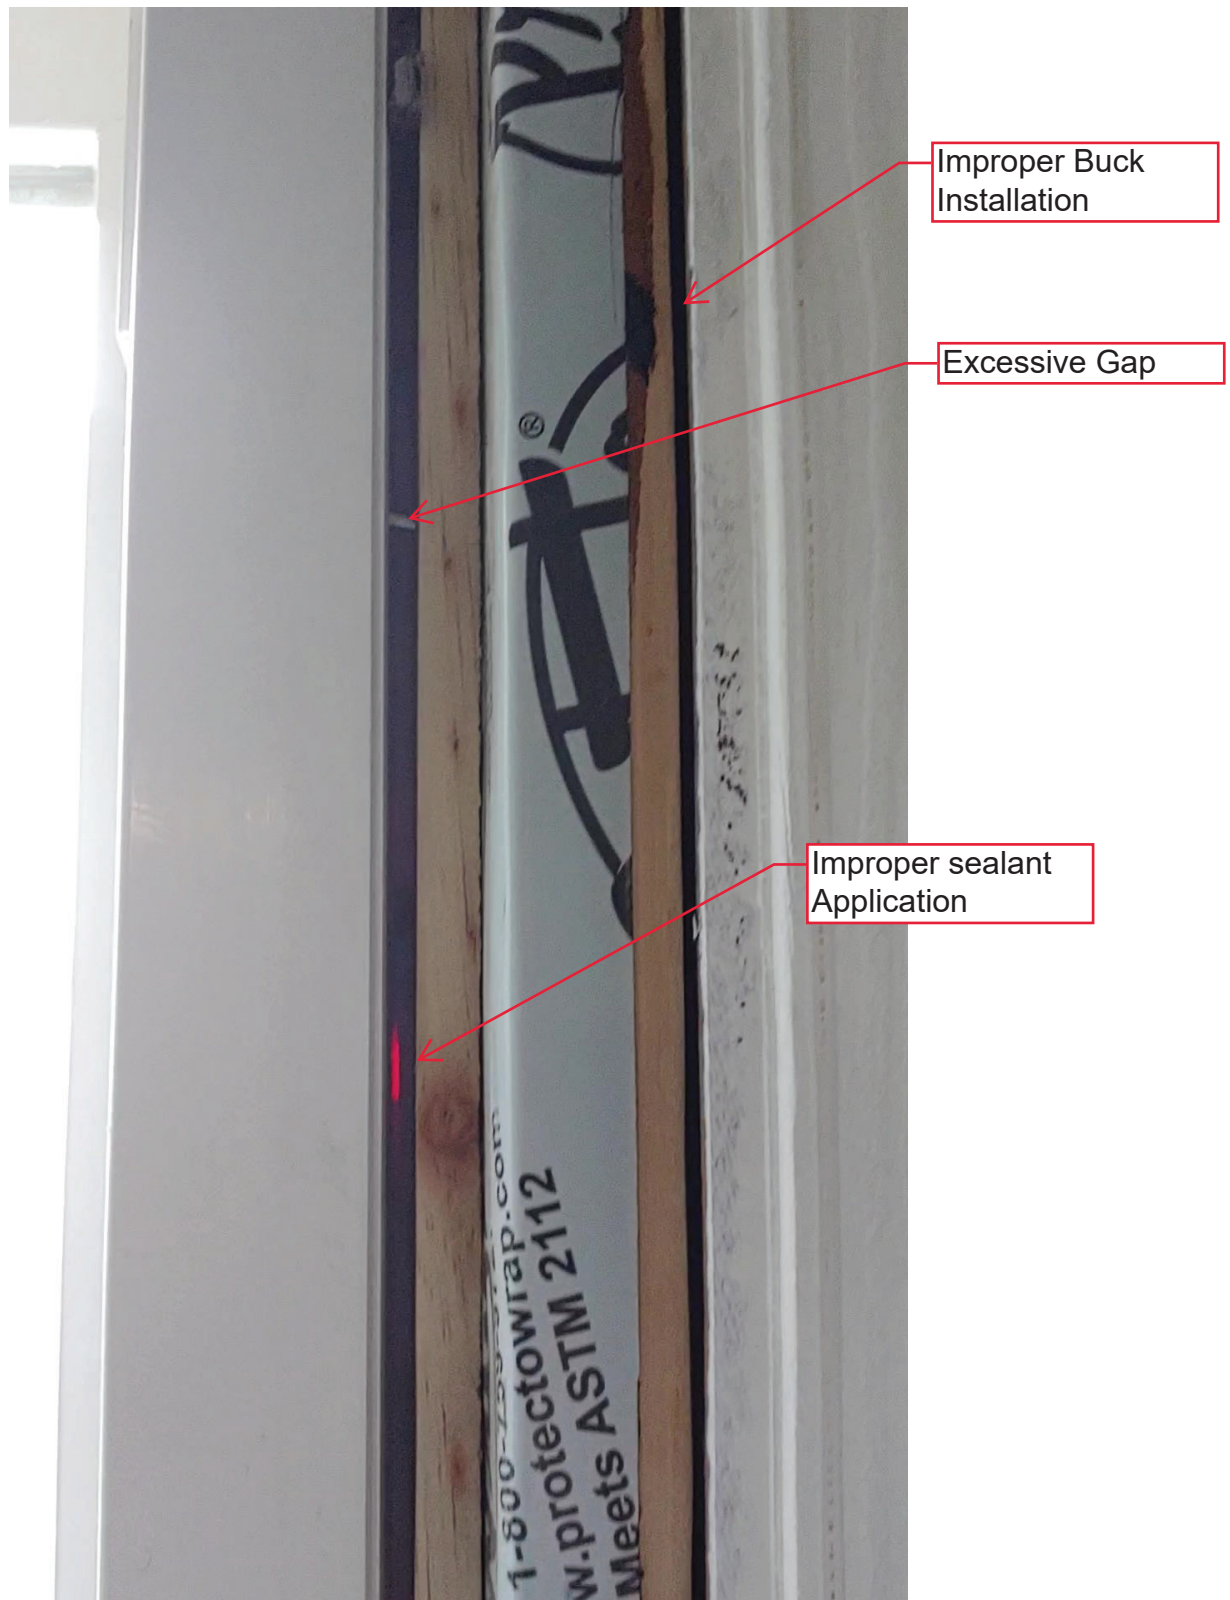
Figure 28 - Opening #5 -Improper Buck Installation  
Missing Shim  
Excessive Shim Gaps

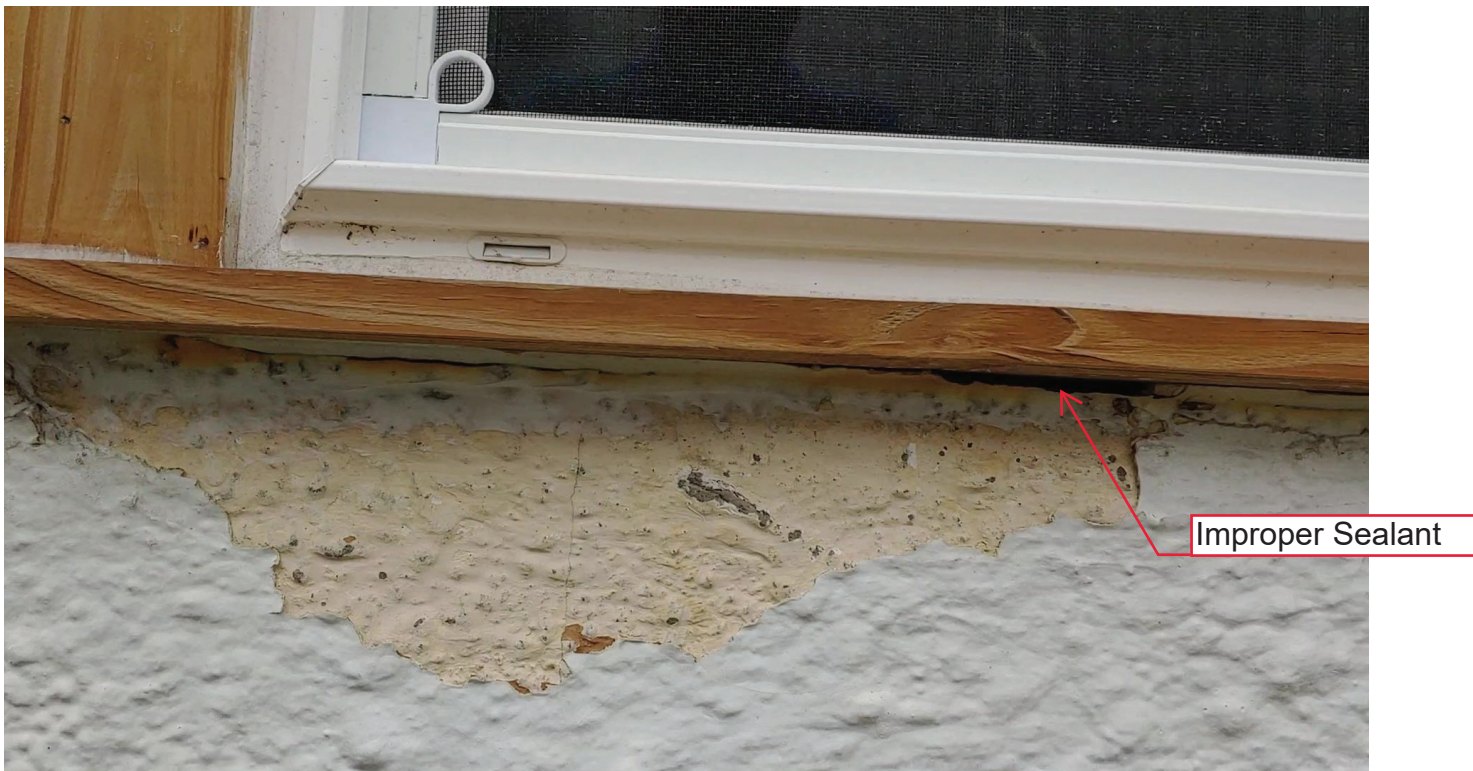
Figure 29 - Opening #5 - Improper Sill Installation; Improper sealant application.

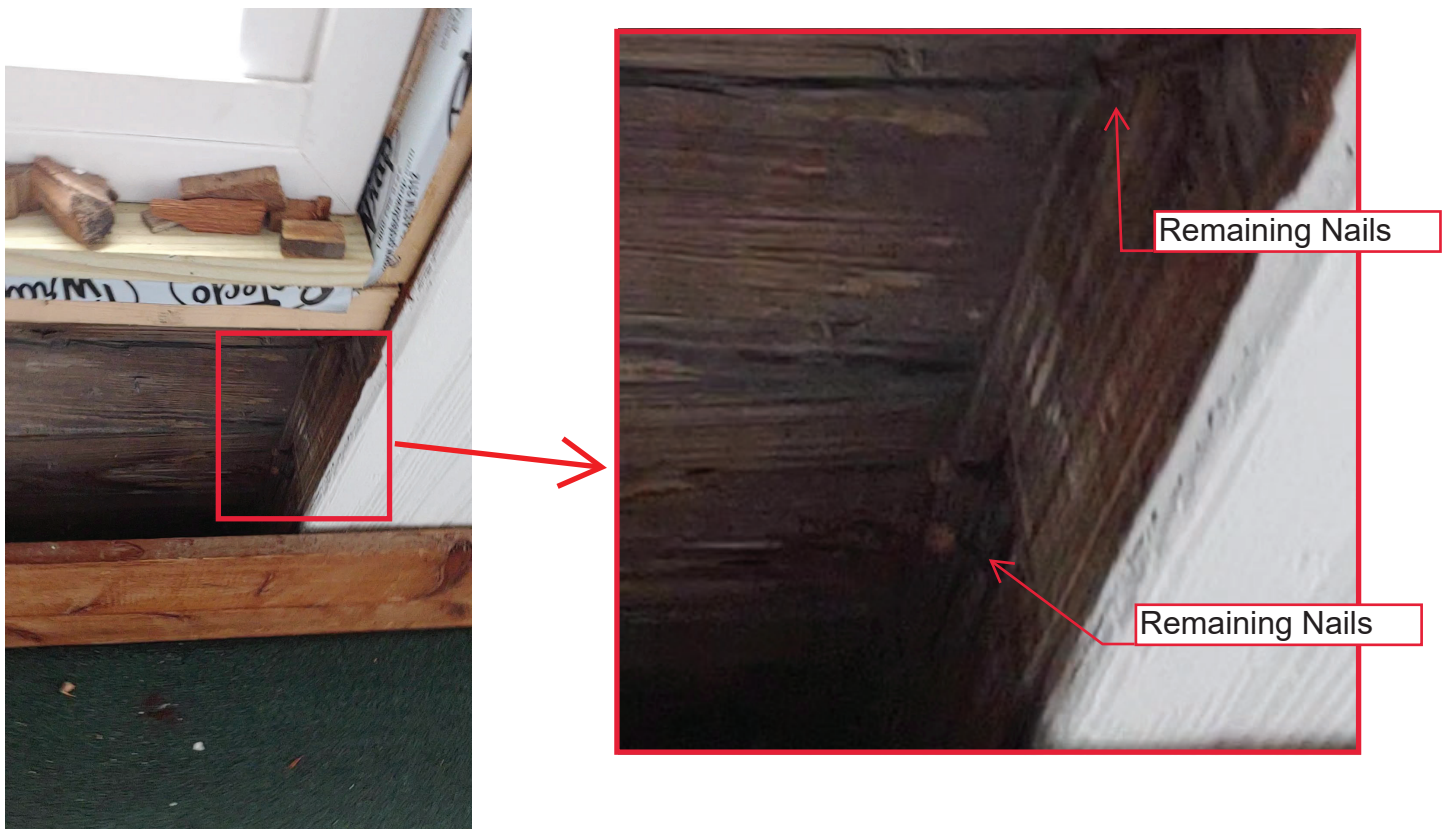
There are missing Cripple Studs below the window (34" span) – See Figure 30

Also missing (2) horizontal members, they have been removed – See Figure 31

Figure 30 - Opening #5 - Missing Trimmer Studs; Missing Jack Studs  
Figure 31 - Opening #5 - Horizontal Blocking Removed;
