### Inspection Report – Structural & Electrical

May 13, 2025

Regarding: Historical Renovation of 1895 Church  
311 SW 3rd St.  
Stuart, FL 34994

Date of Inspection: 04/04/25

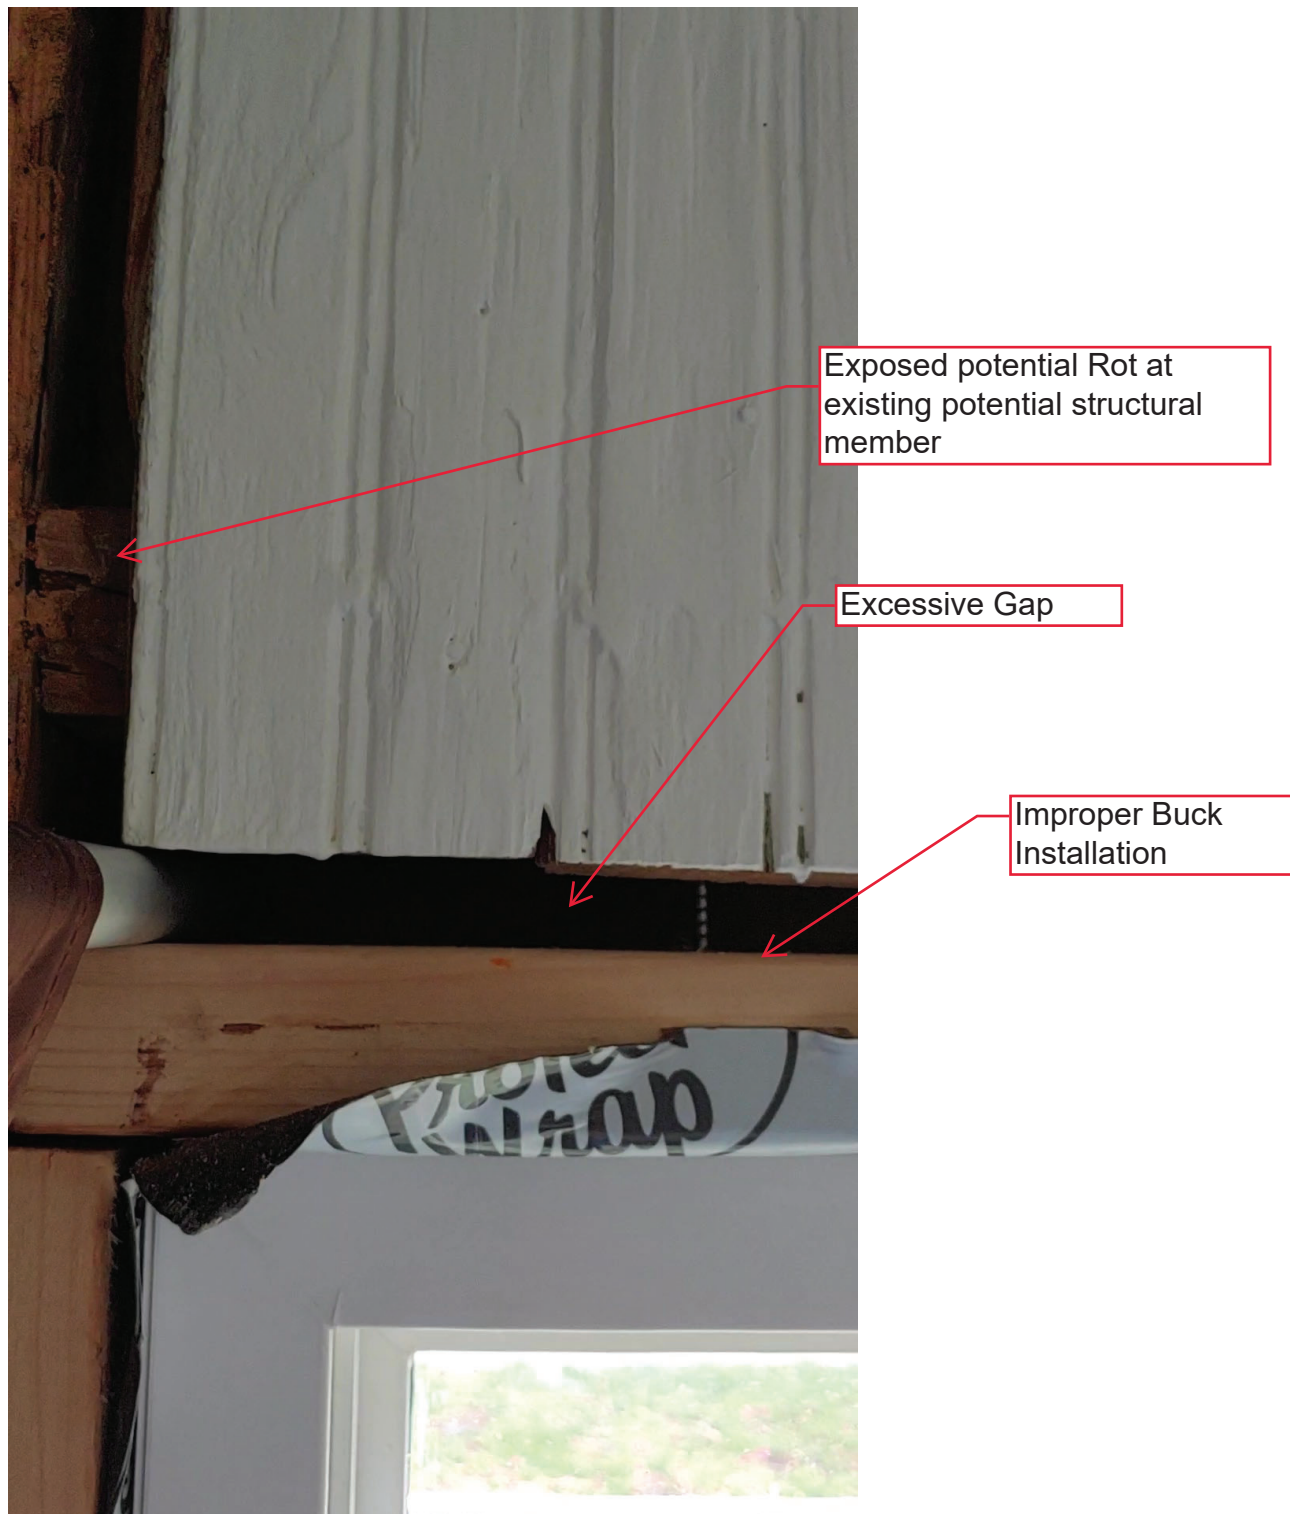
Improper/Missing Header with Excessive gaps, Missing Shims – See Figure 32

Figure 32 - Opening #6 - Improper Buck Installation;  
Missing Shim  
Excessive Gaps

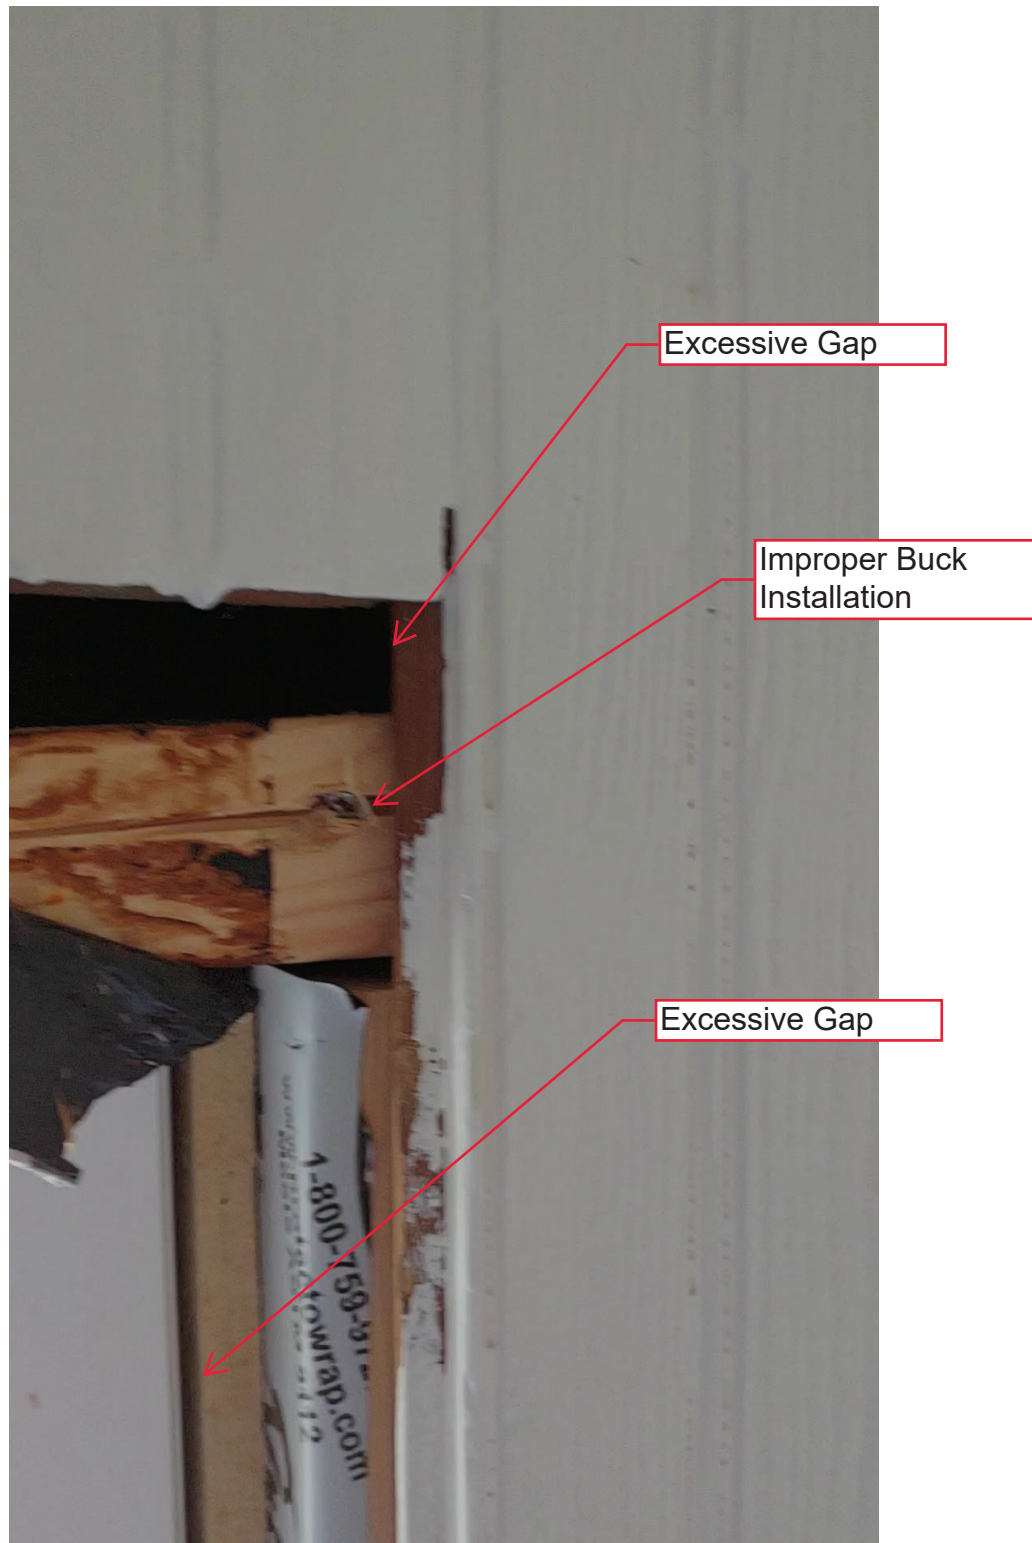
Improper Buck and Shim Installation – See Figure 33

Figure 33 - Opening #6 - Improper Buck Installation;  
Missing Shim  
Excessive Gaps

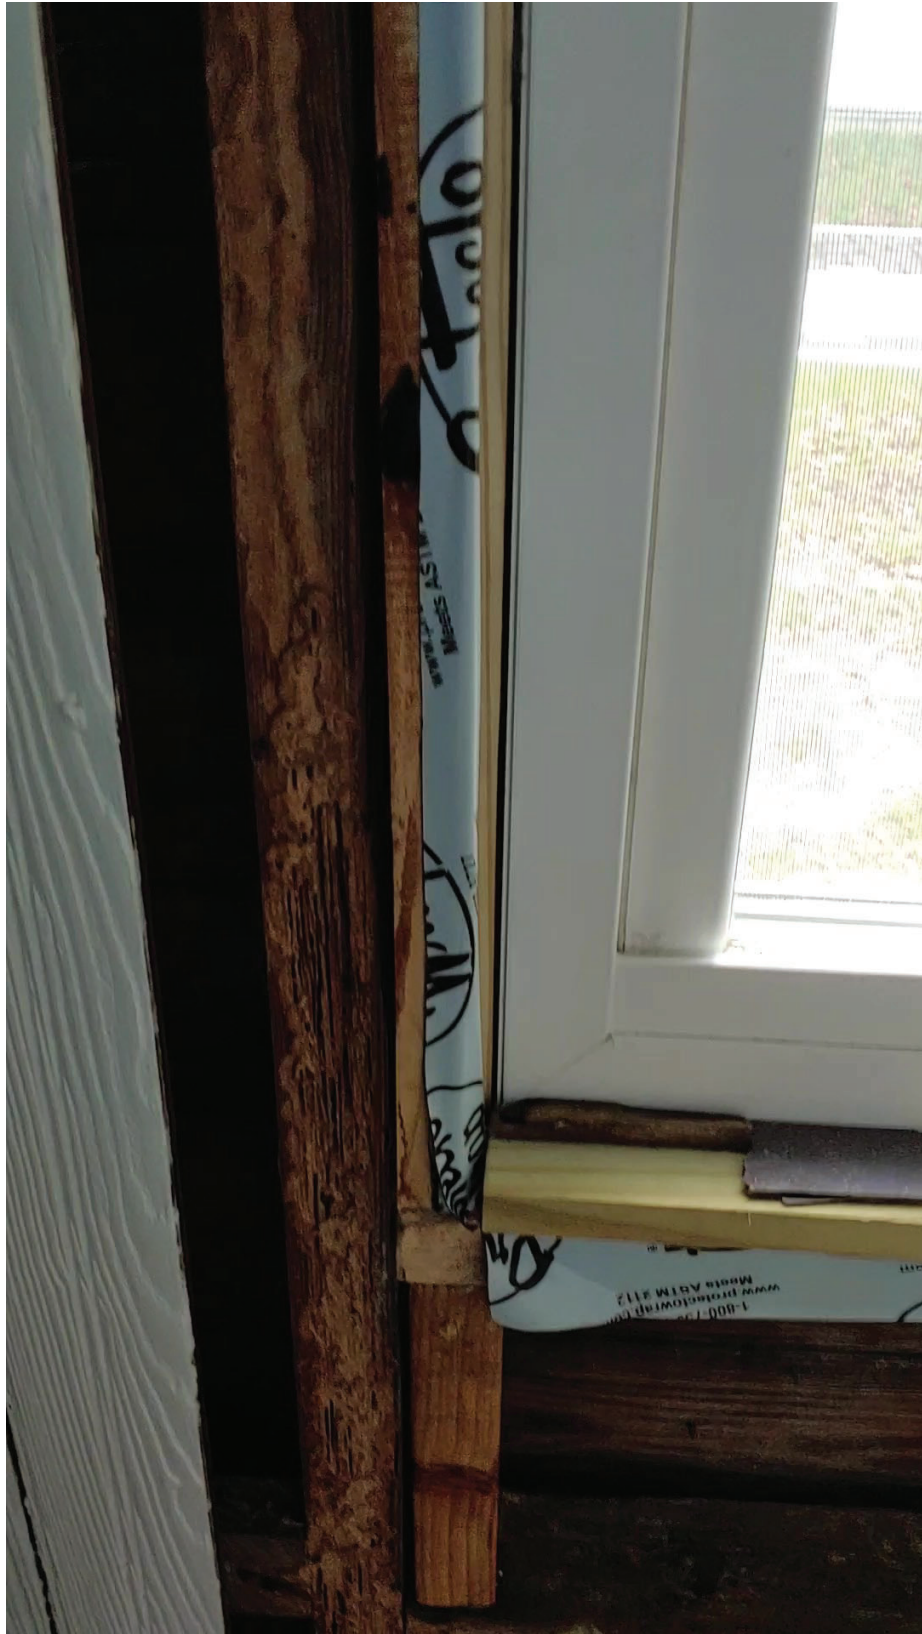
Left Trimmer Rot Buck or Sister? – See Figure 34

Figure 34 - Opening #6 - Improper Buck Installation;  
Trimmer Rot? Buck or Sister?

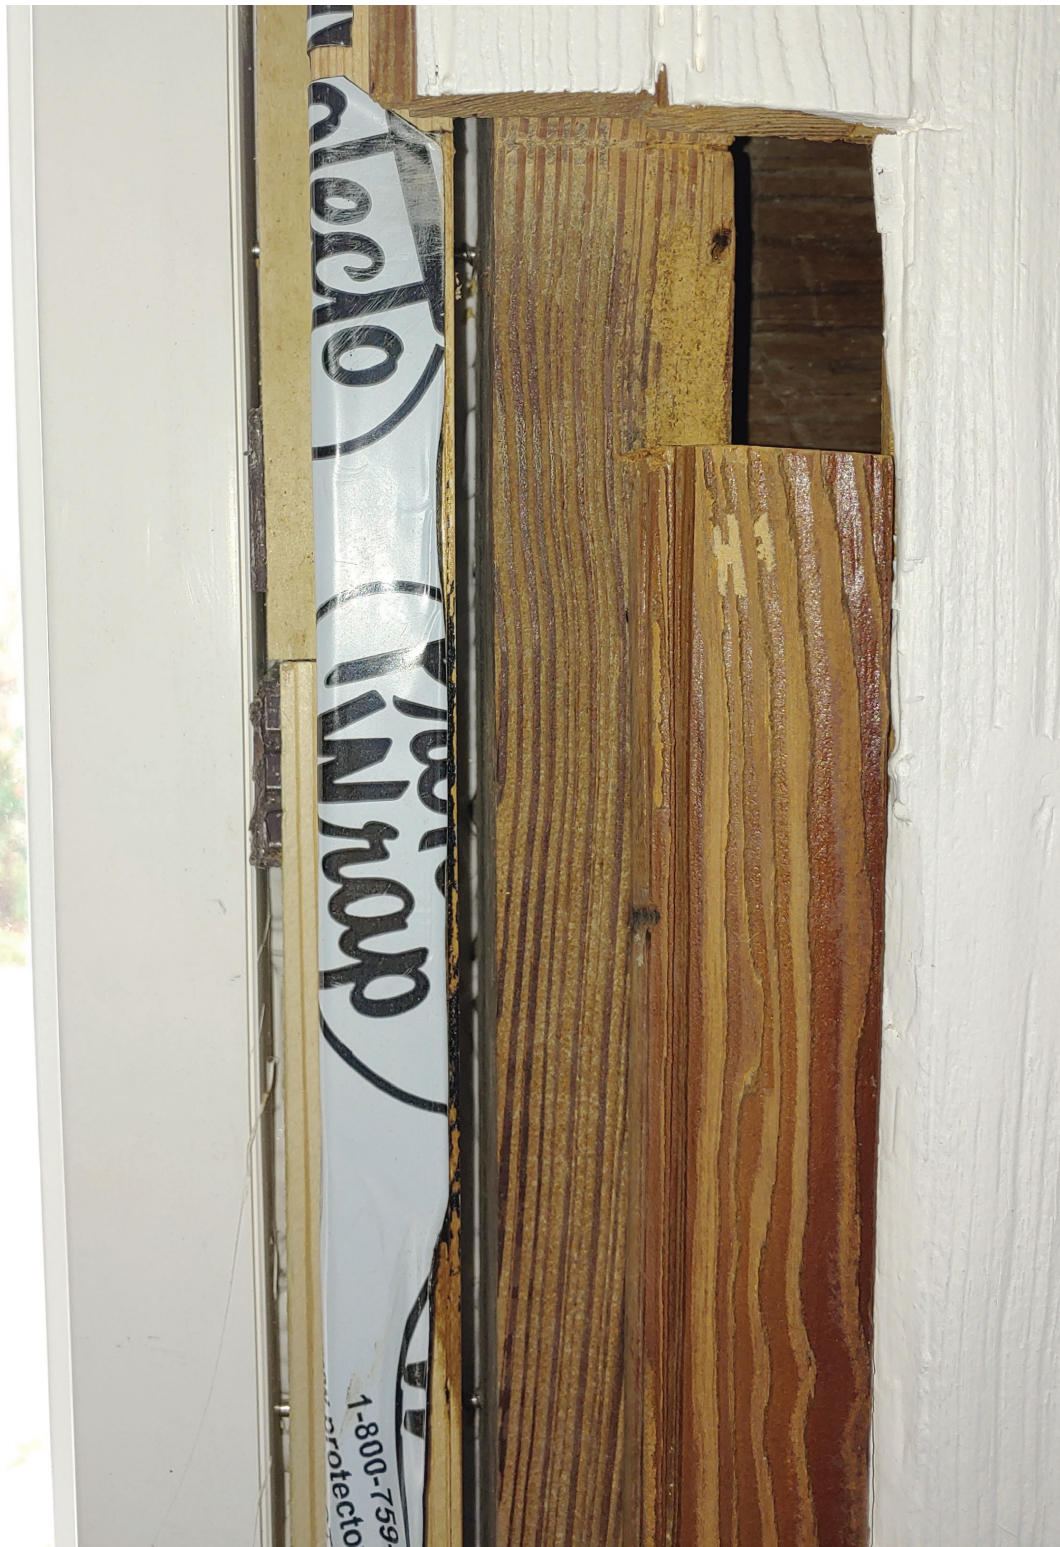
Right side improper buck installation – See Figure 35

Figure 35 - Opening #6 - Improper Buck Installation  
Missing Shims & Excessive Space

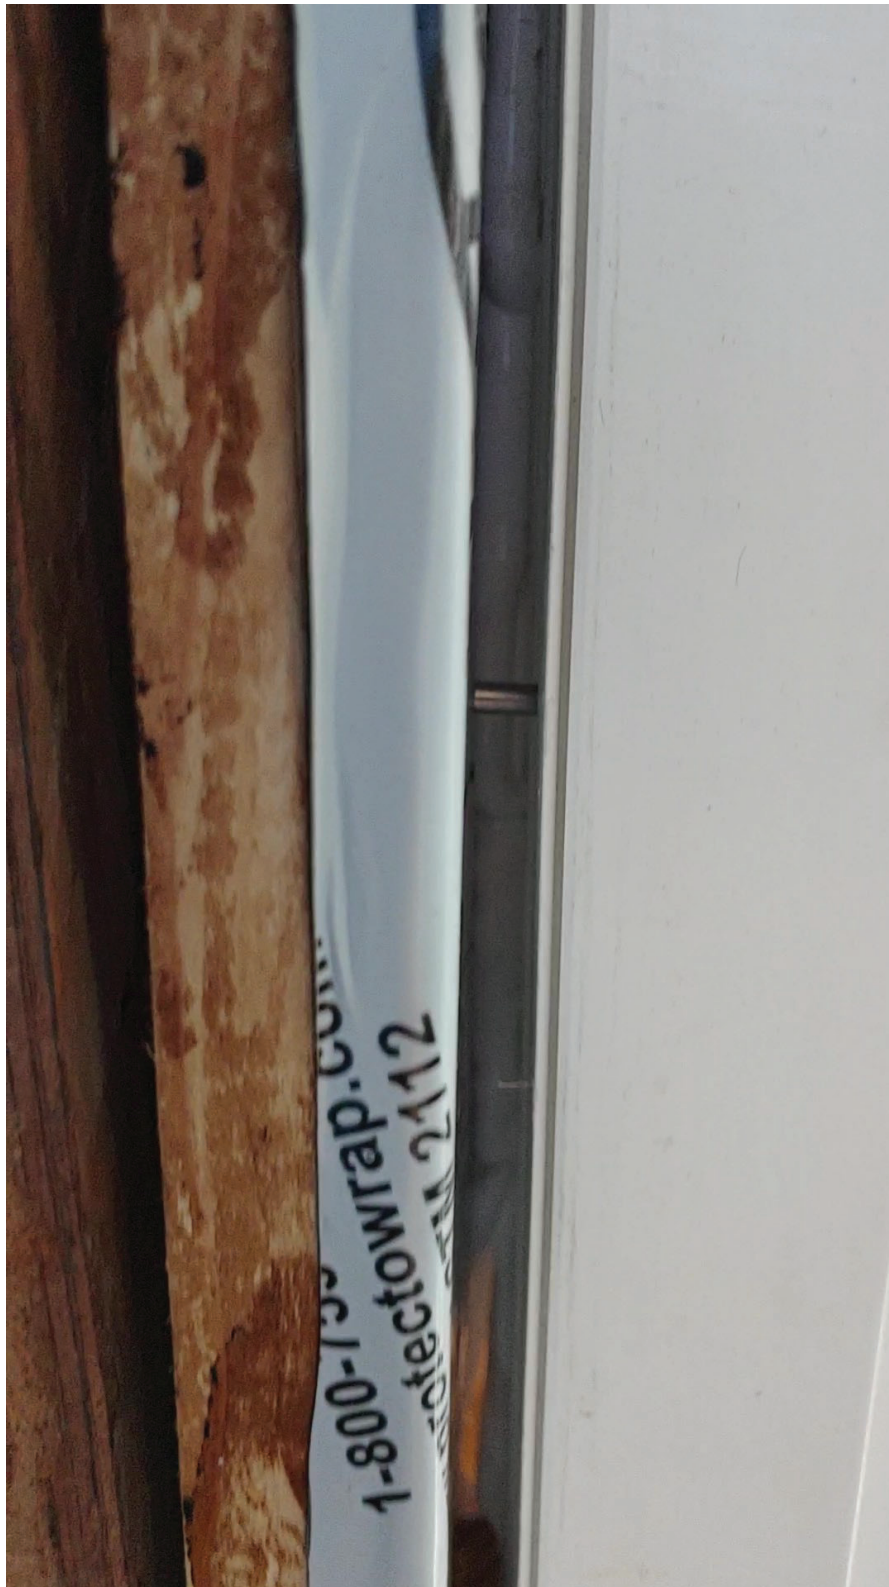
Shim Gap, Improper buck Installation, missing shims – See Figure 36

Figure 36 - Opening #6 - Improper Buck Installation  
Missing Shims & Excessive Space

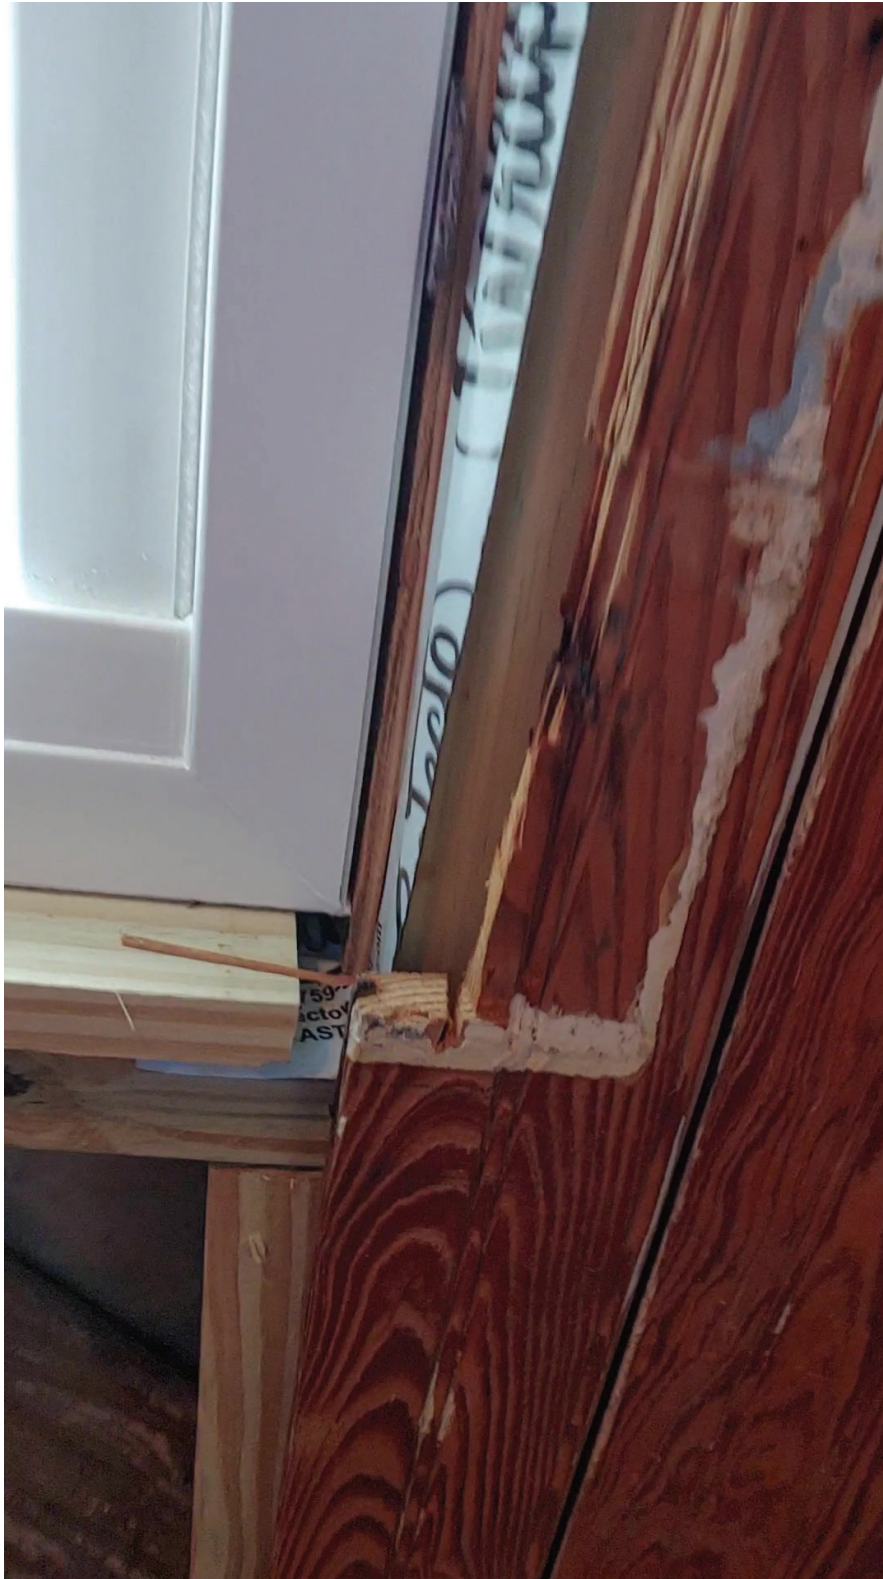
Right bottom corner Sill, Window carrying load, excessive shims, missing anchors – See Figure 37

Figure 37 - Opening #7 - Improper Trimmer/Buck Installation  
Excessive Space

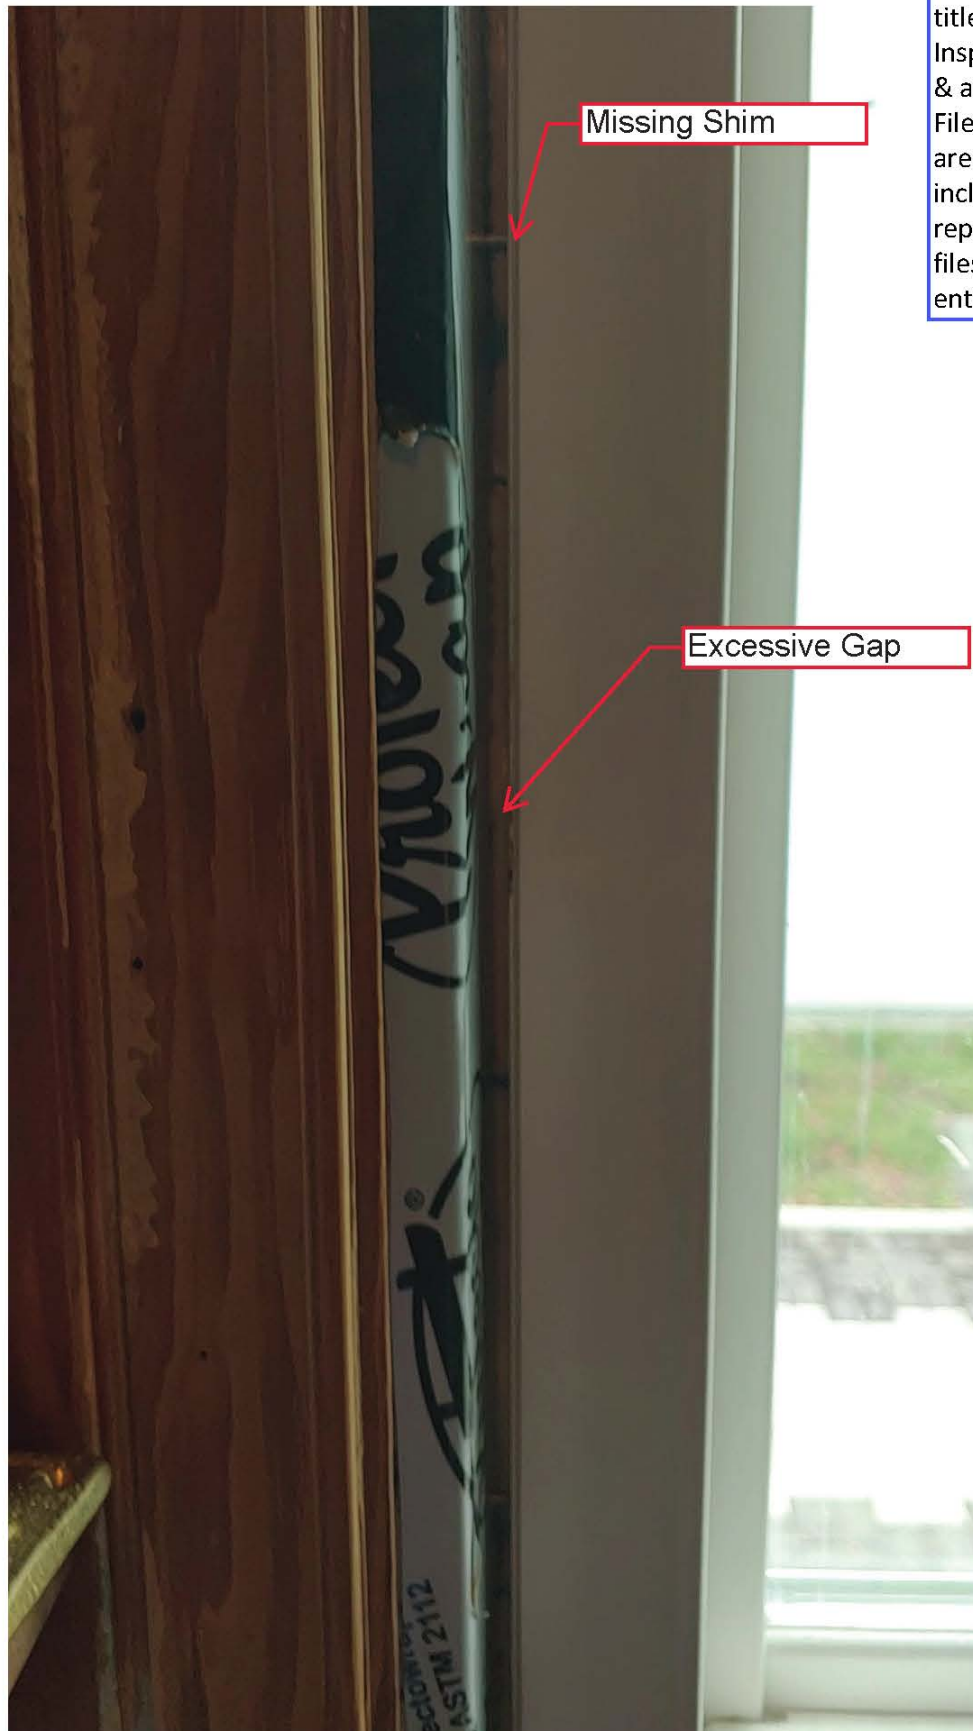
Excessive gaps at sides, missing shims – See Figure 38

Figure 38 - Opening #7 - Excessive Gaps, Missing Shims

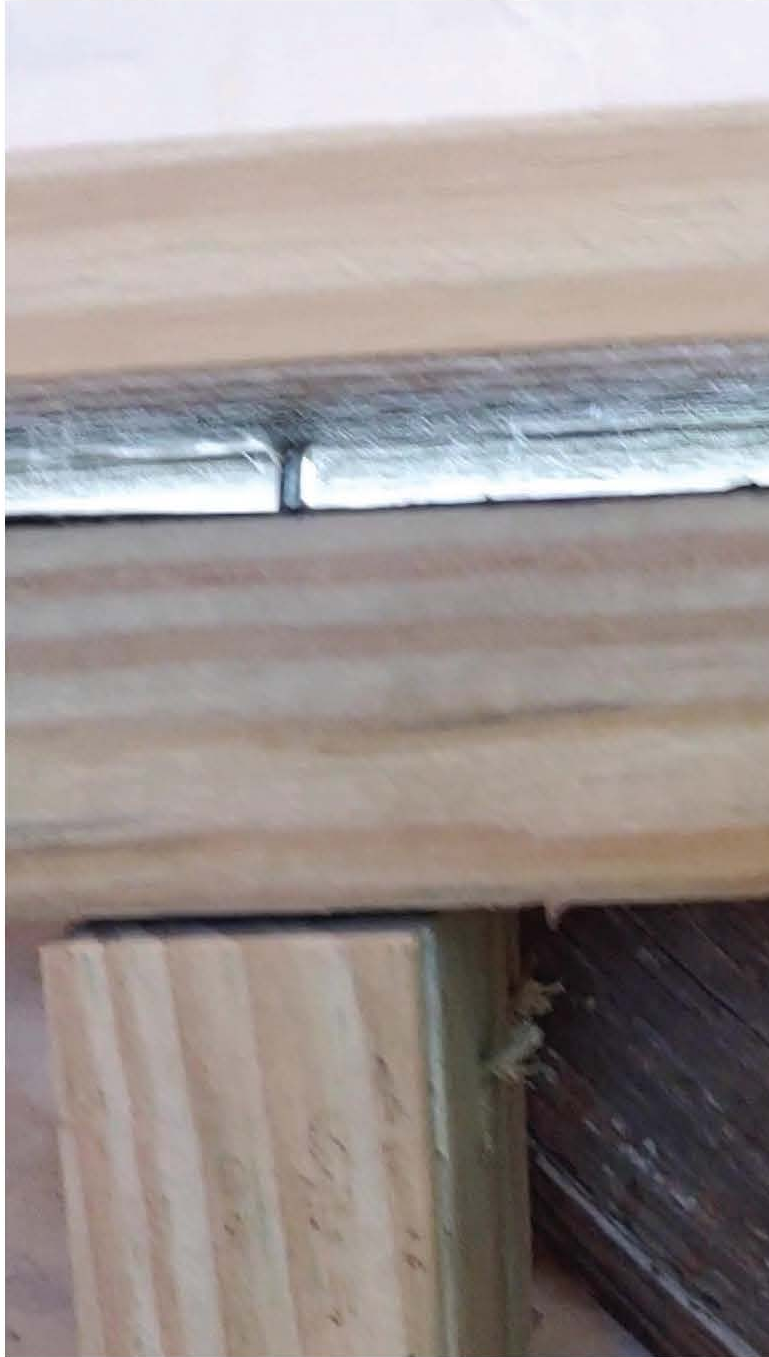
Shim Gap and bottom - missing shims – See Figure 39

Figure 39 - Opening #7 - Excessive Gaps, Missing Shims

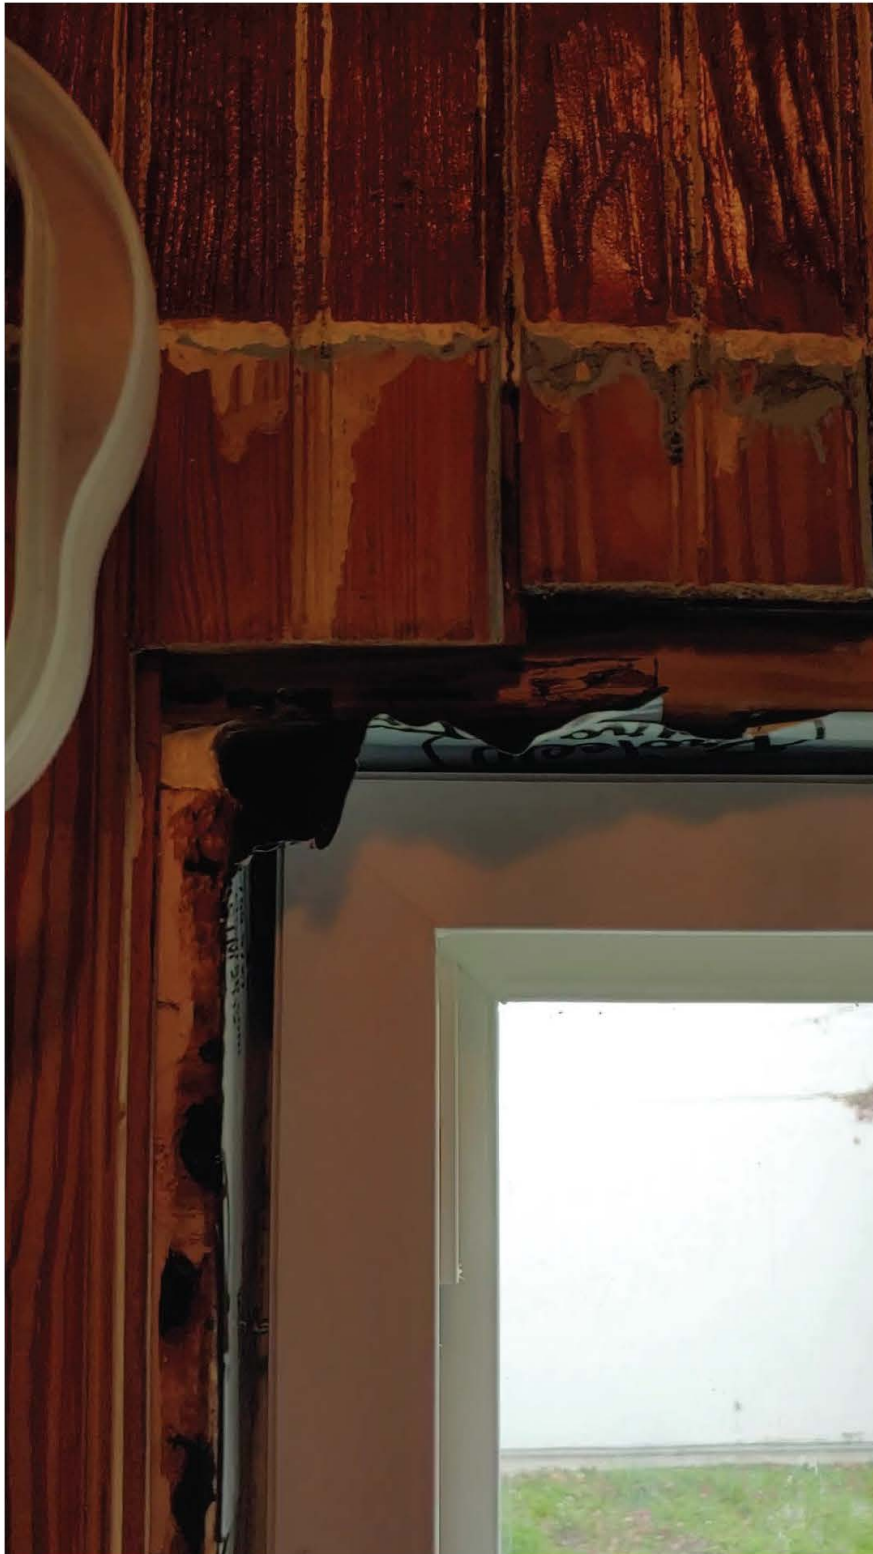
Left Corner Trimmer & Header Rot – See Figure 40

Figure 40 - Opening #7 - Wood Rot at Upper Left Hand Corner  
- Excessive Shim Spacing  
- Missing Shims

The Hamiltons have reached out with a couple of comments about the report, Namely the room designations and that Window 7 does not have Rot.

As Room Designations are not a functional part of the report I am inclined to leave the designations, as for the Rot statement I will need to go back to view my notes and videos to see if I carried that over from a previous window as a typo.

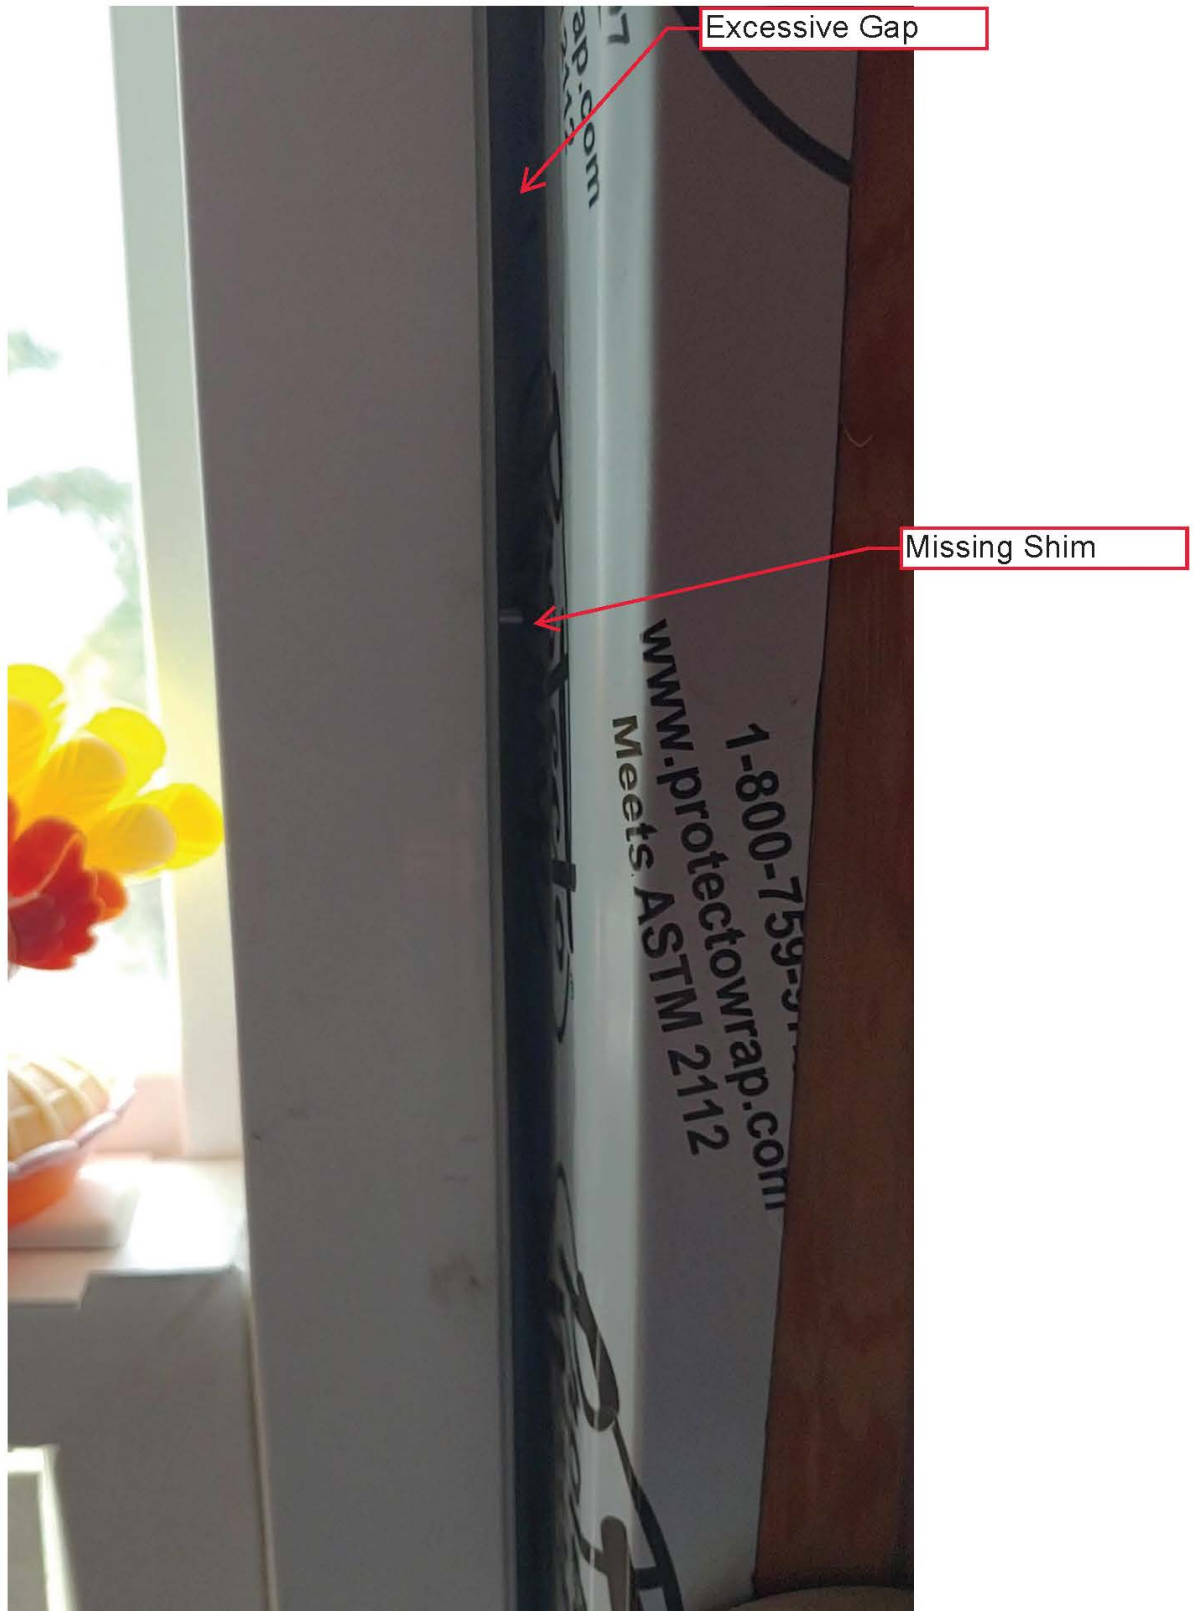
Excessive gaps at left & right, missing shims – See Figure 41

Figure 41 - Opening #8 - Excessive Gaps, Missing Shims

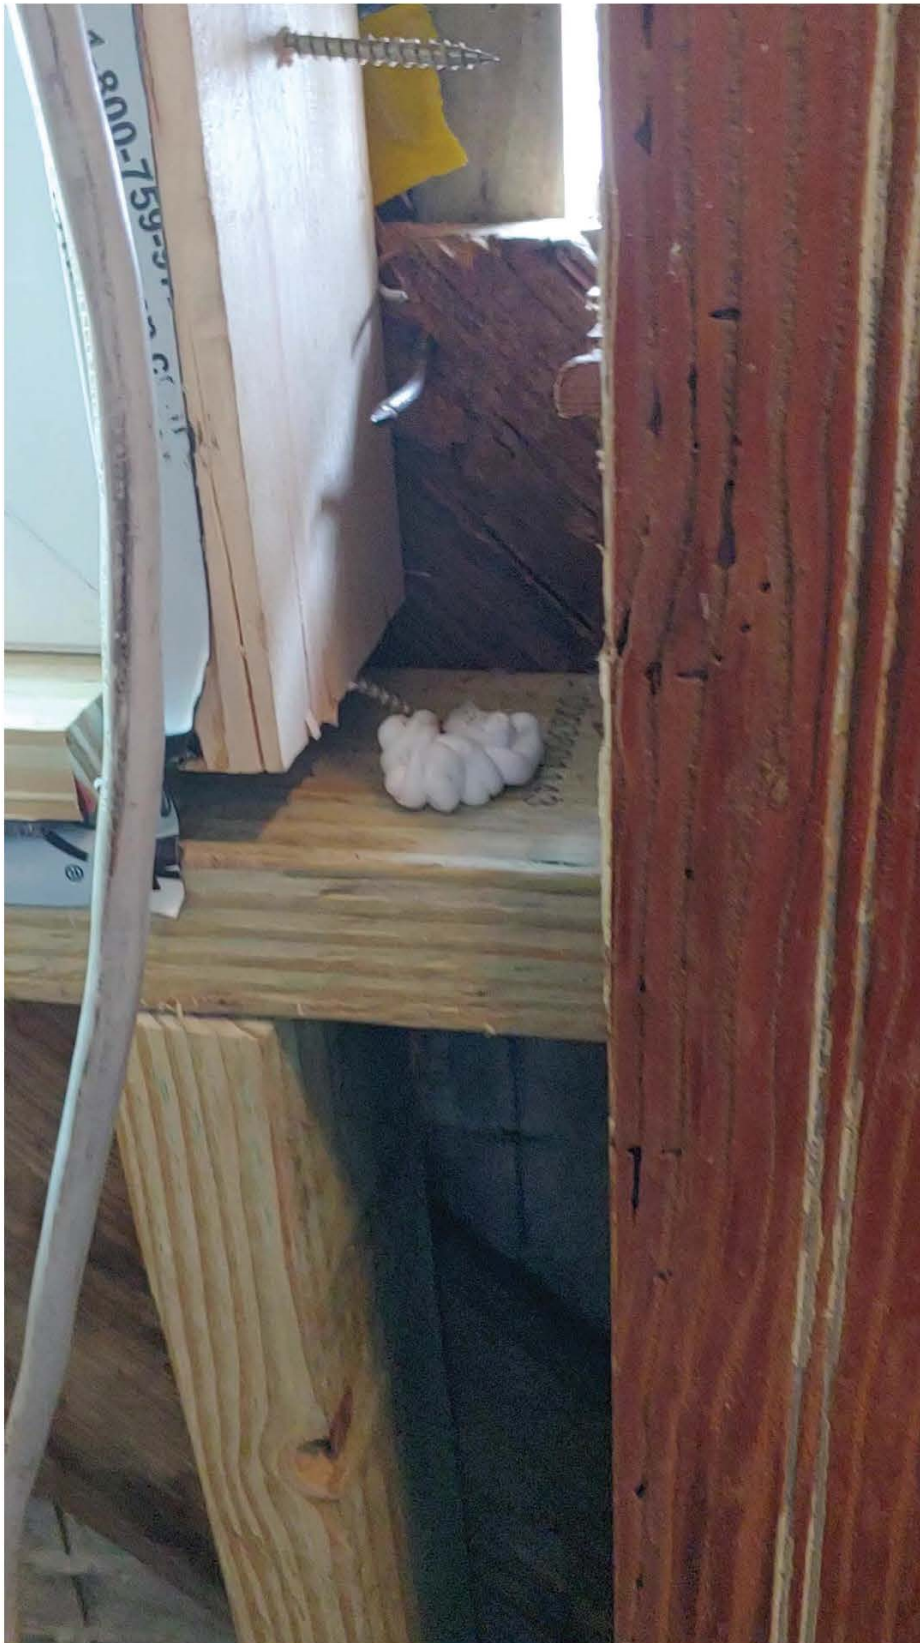
Figure 42 - Opening #8 - Improper Buck Installation

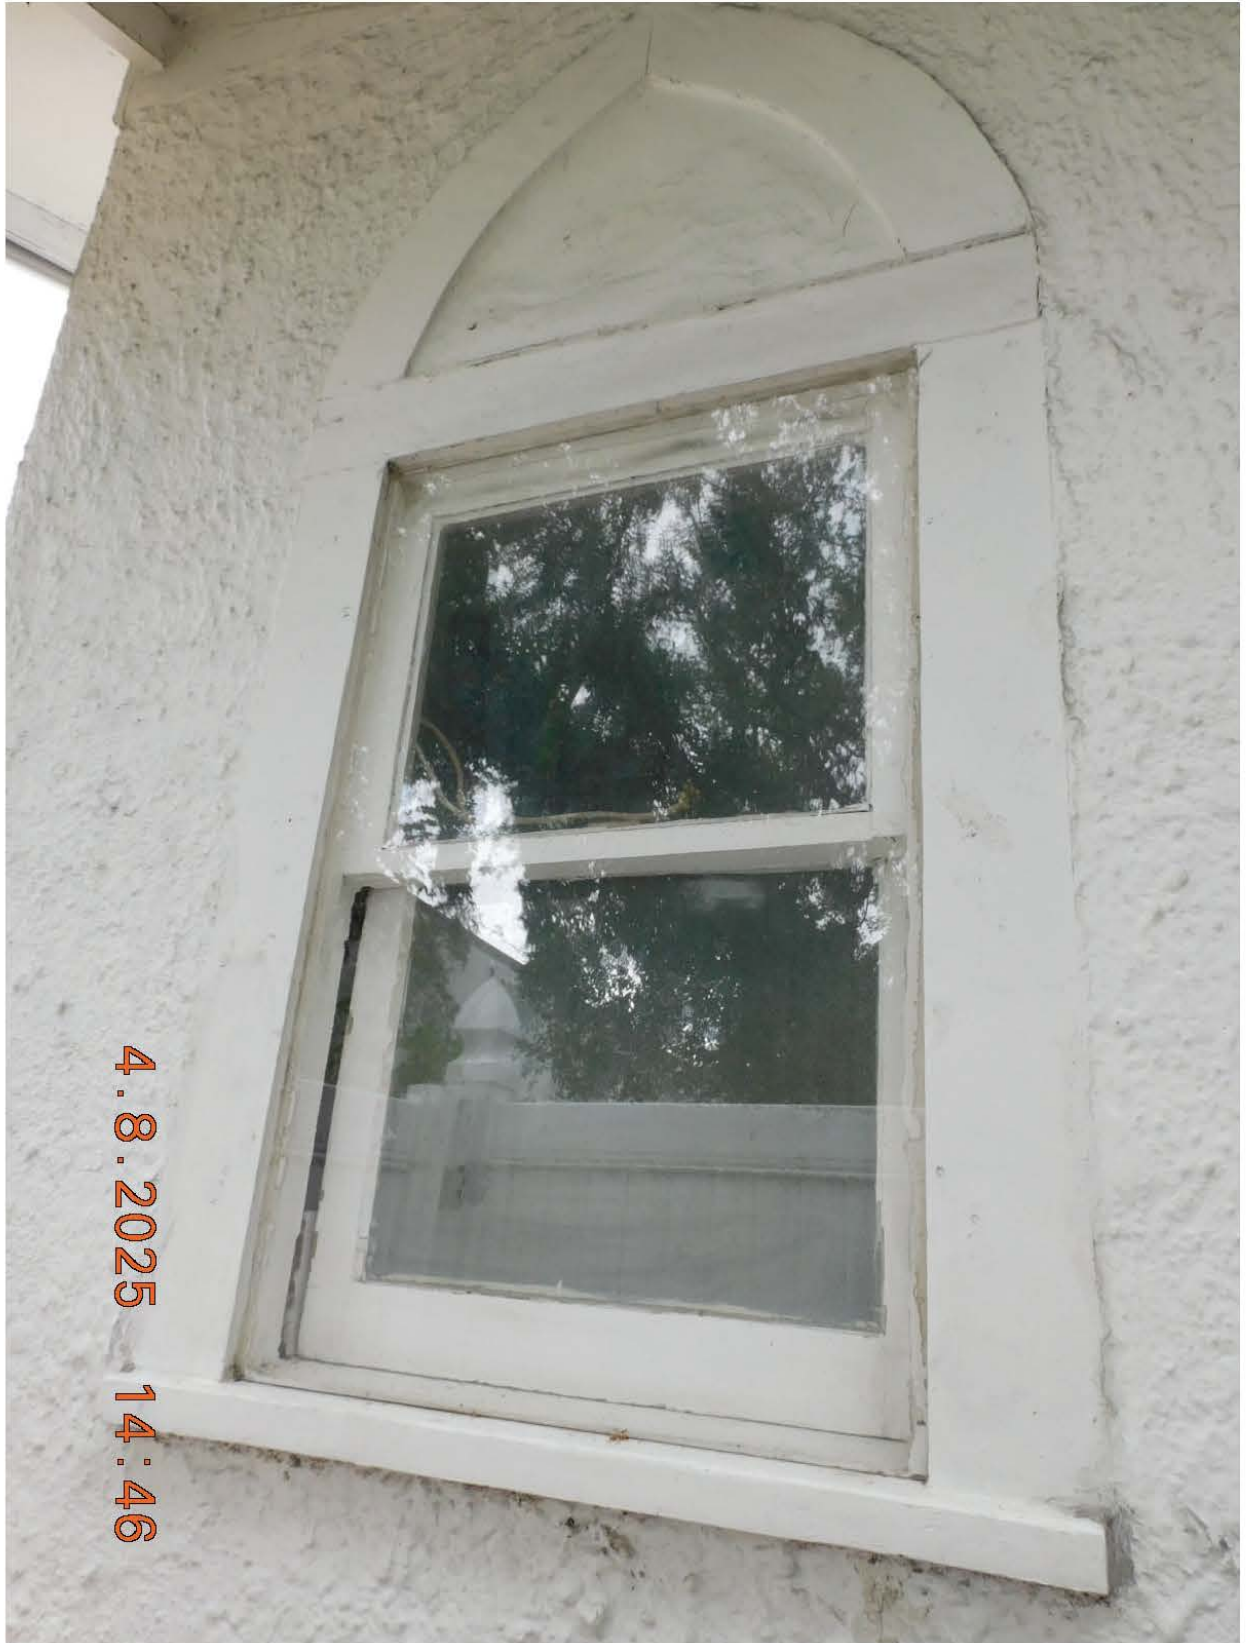
Window #9 – Not replaced – See Figure 43

Figure 43 - Opening #9 - Original Window

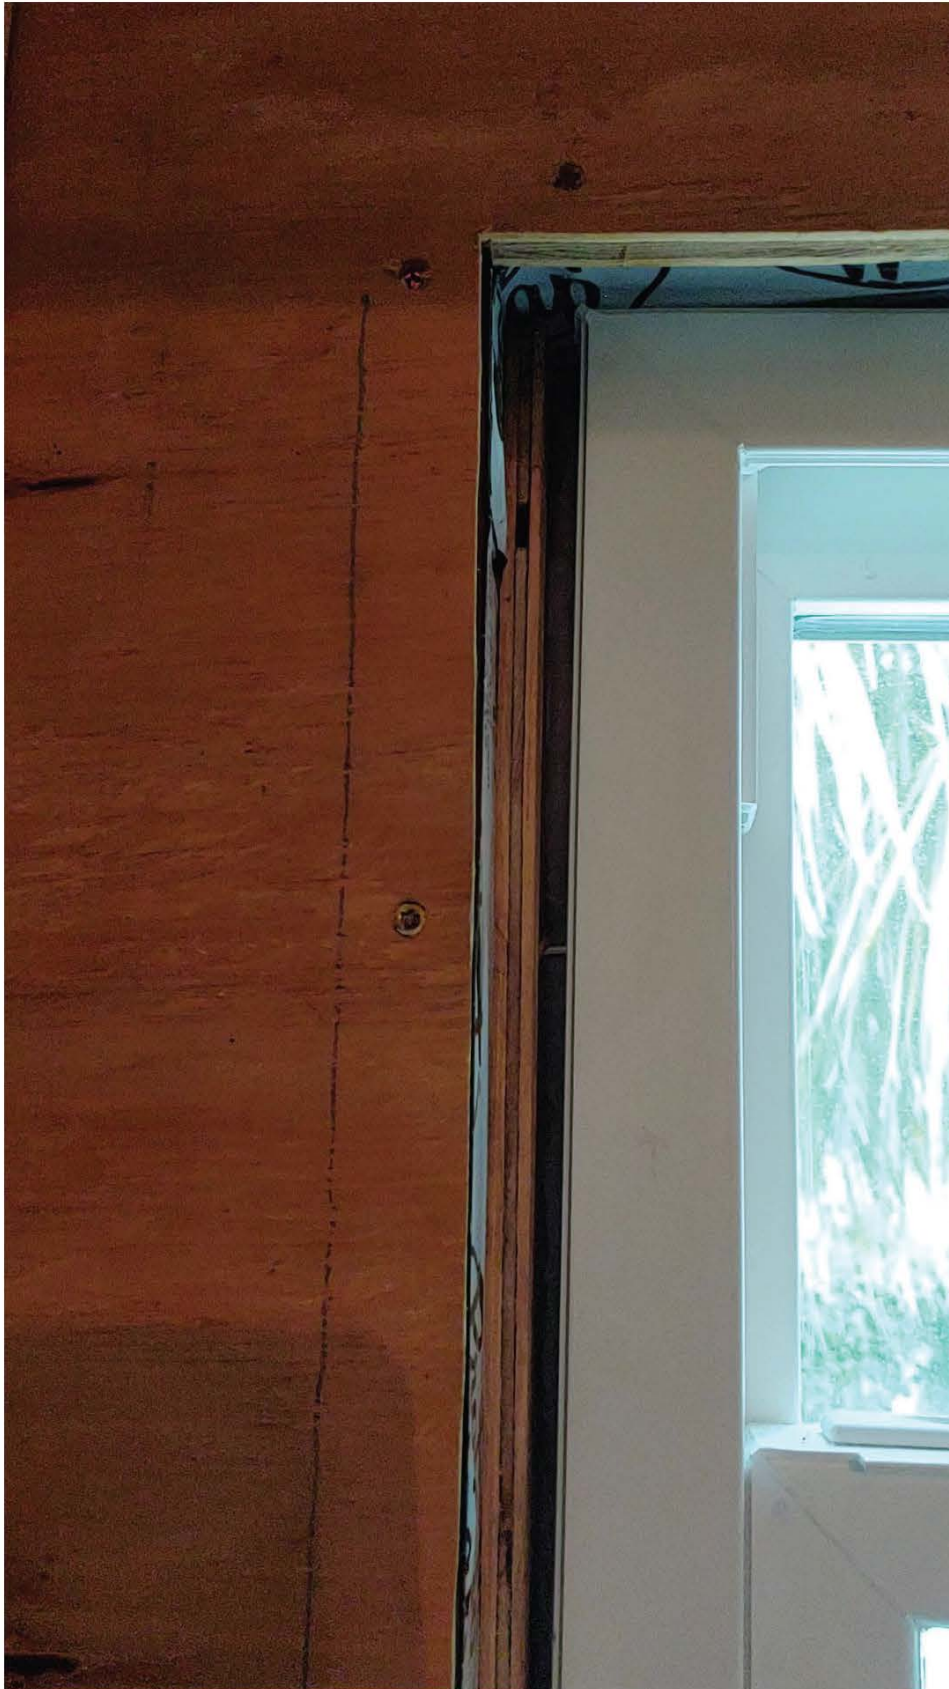
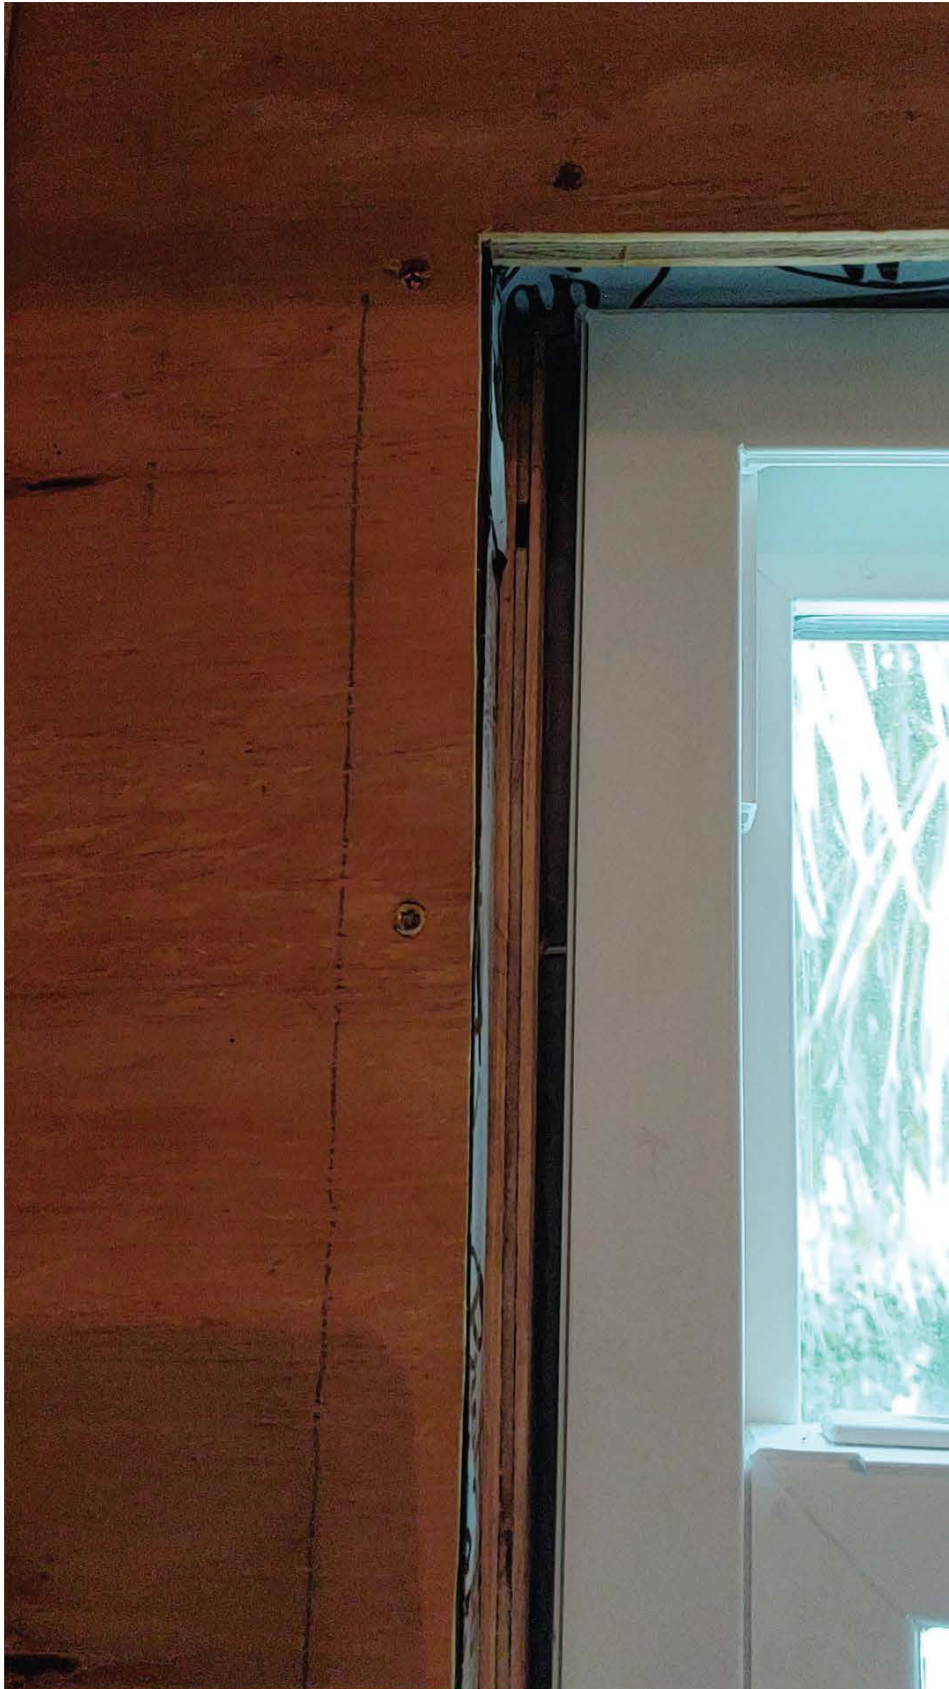
Excessive gaps at right, missing shims – See Figure 45

Figure 45 - Opening #11 - Excessive Gaps, Missing Shims
