### Inspection Report – Structural & Electrical

May 13, 2025

Regarding: Historical Renovation of 1895 Church  
311 SW 3rd St.  
Stuart, FL 34994

Date of Inspection: 04/04/25

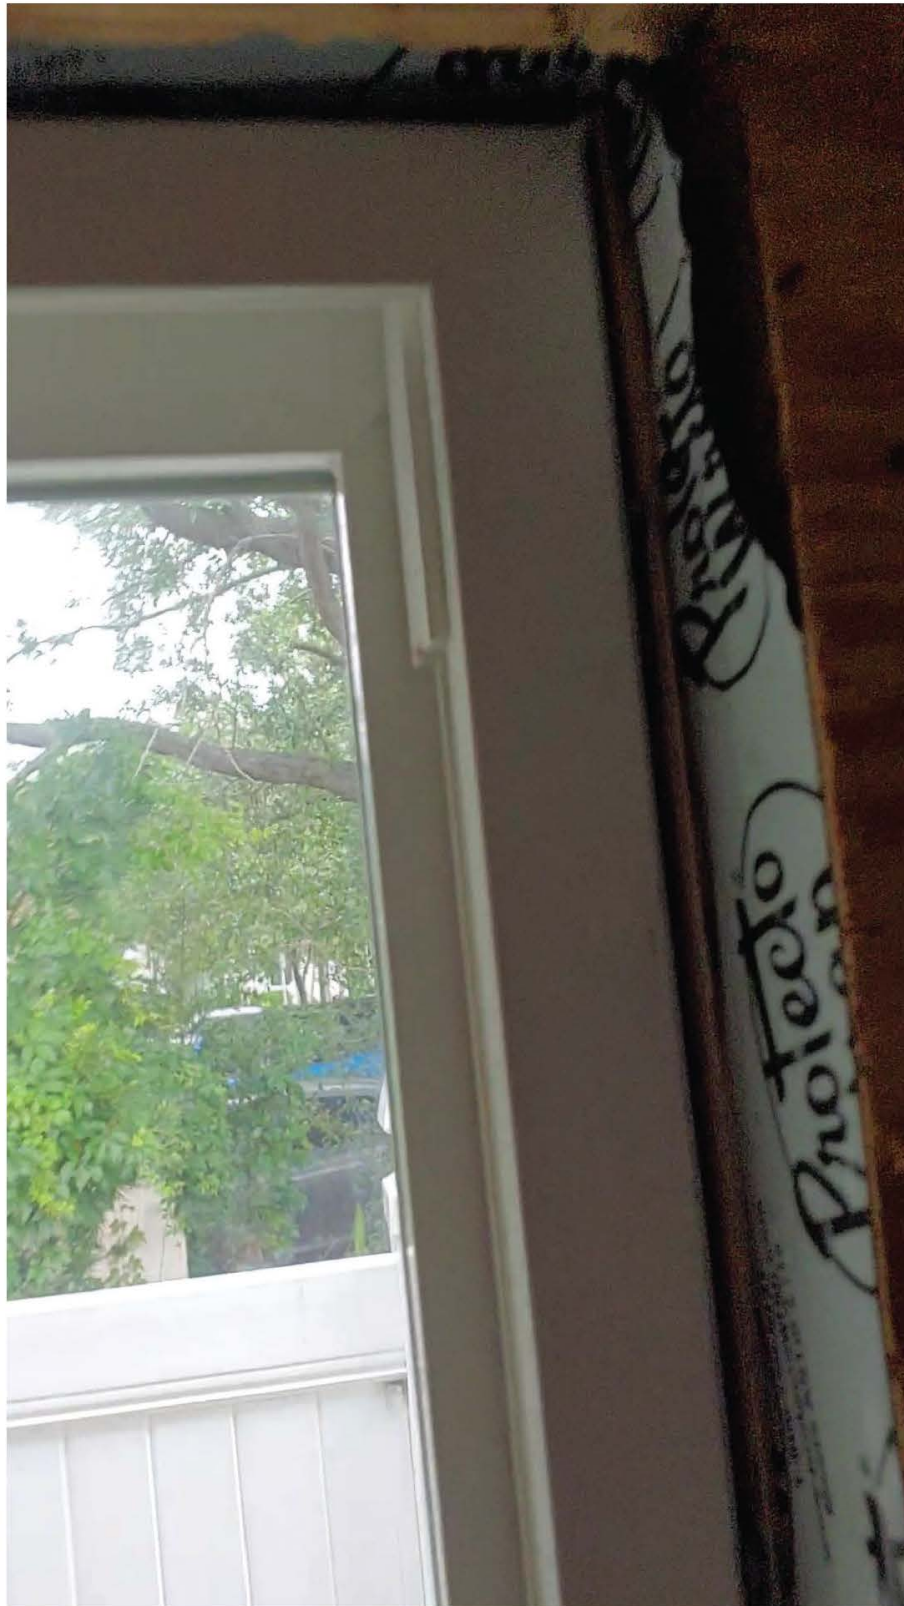
Excessive gaps at left & right, missing shims – See Figure 44

Figure 44 - Opening #10 - Excessive Gaps, Missing Shims

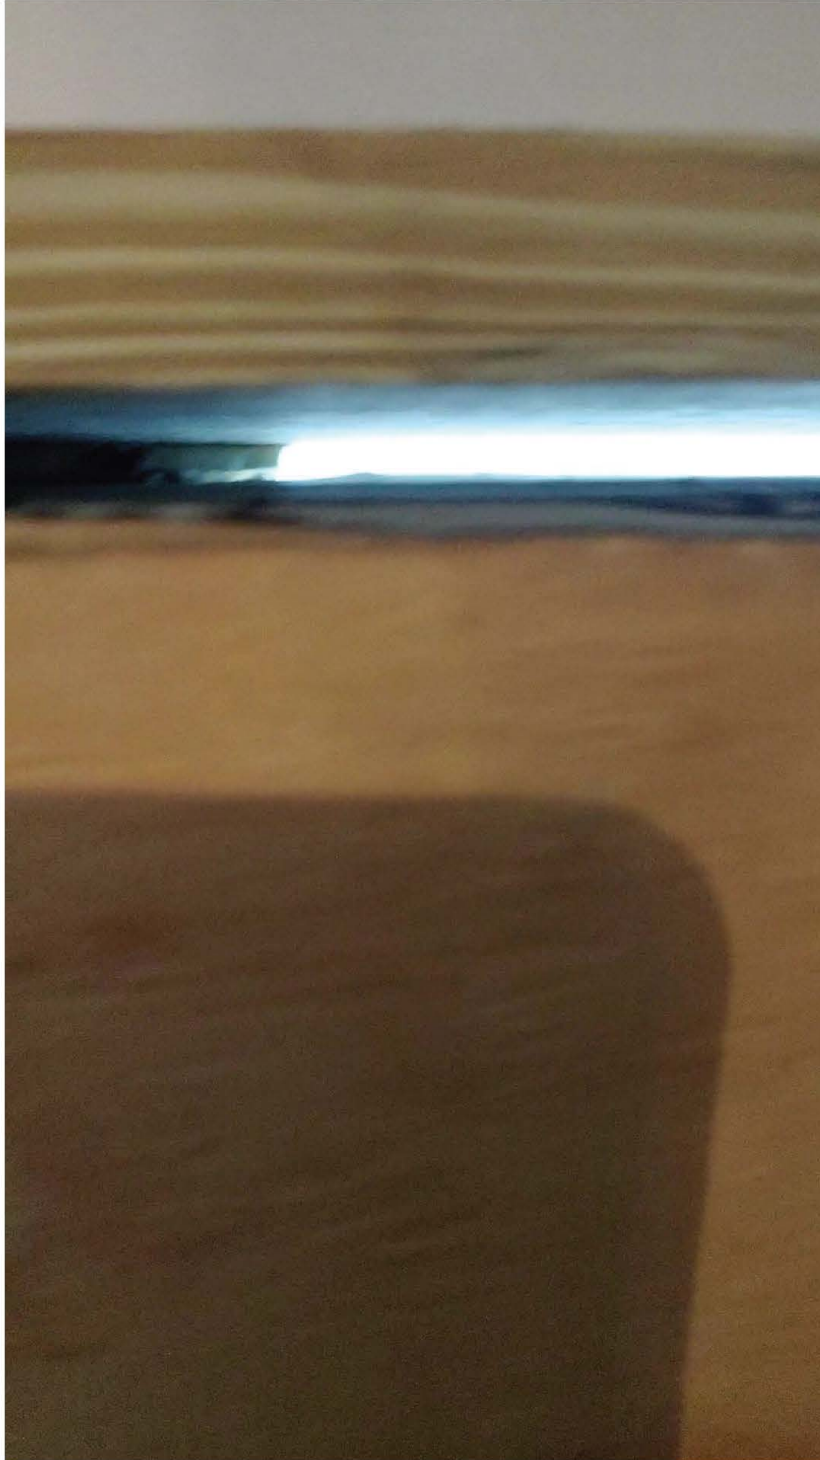
Figure 46 - Opening #11 - Excessive Gaps at Sill  
- Missing Shims  
- Improper Sealant Application

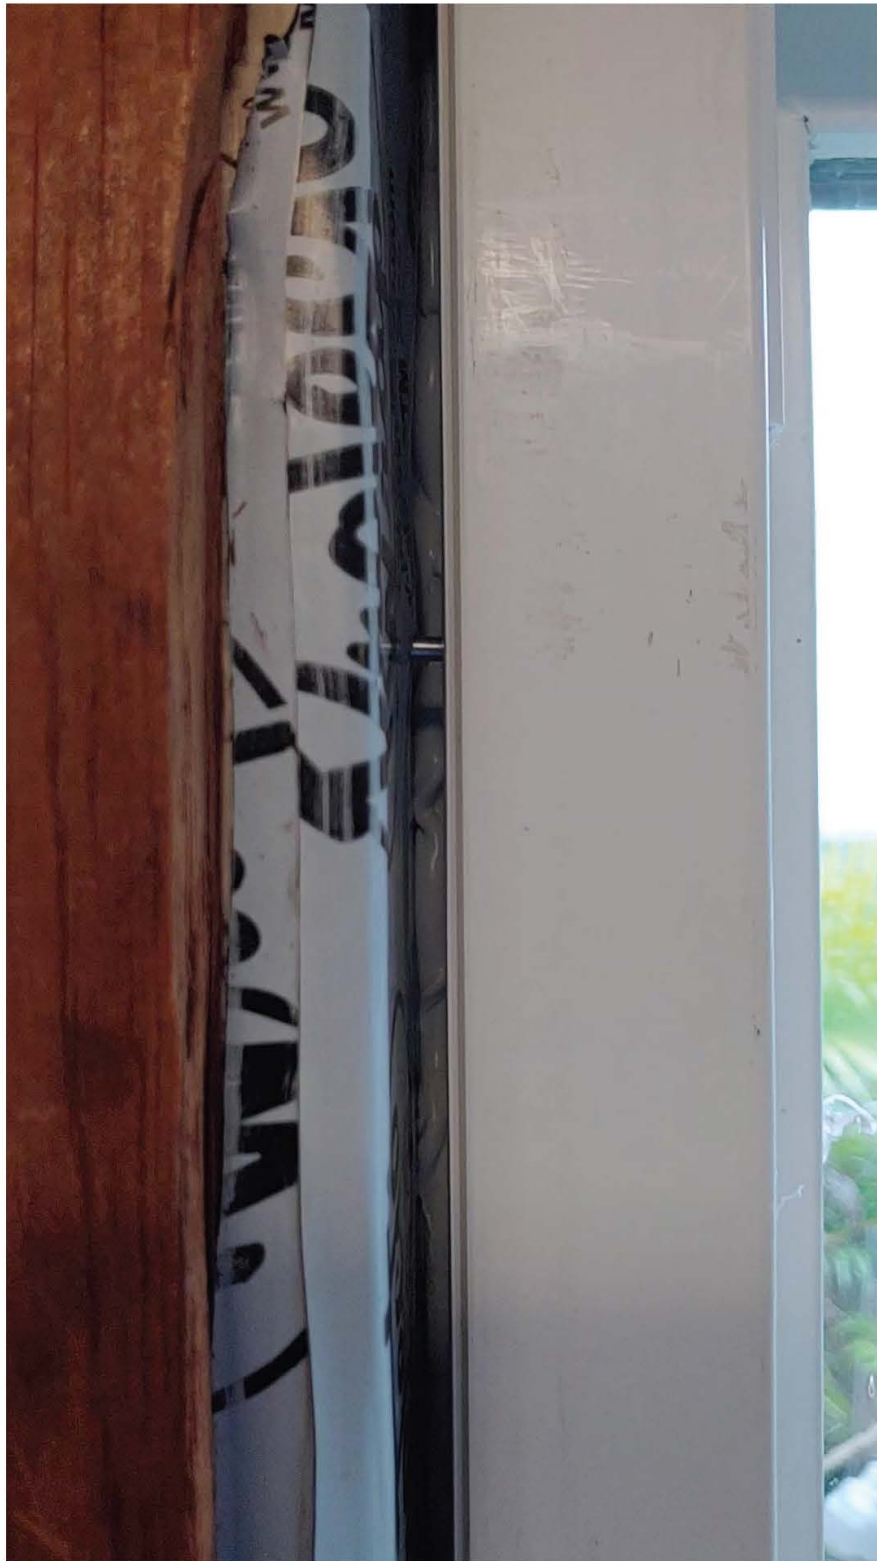
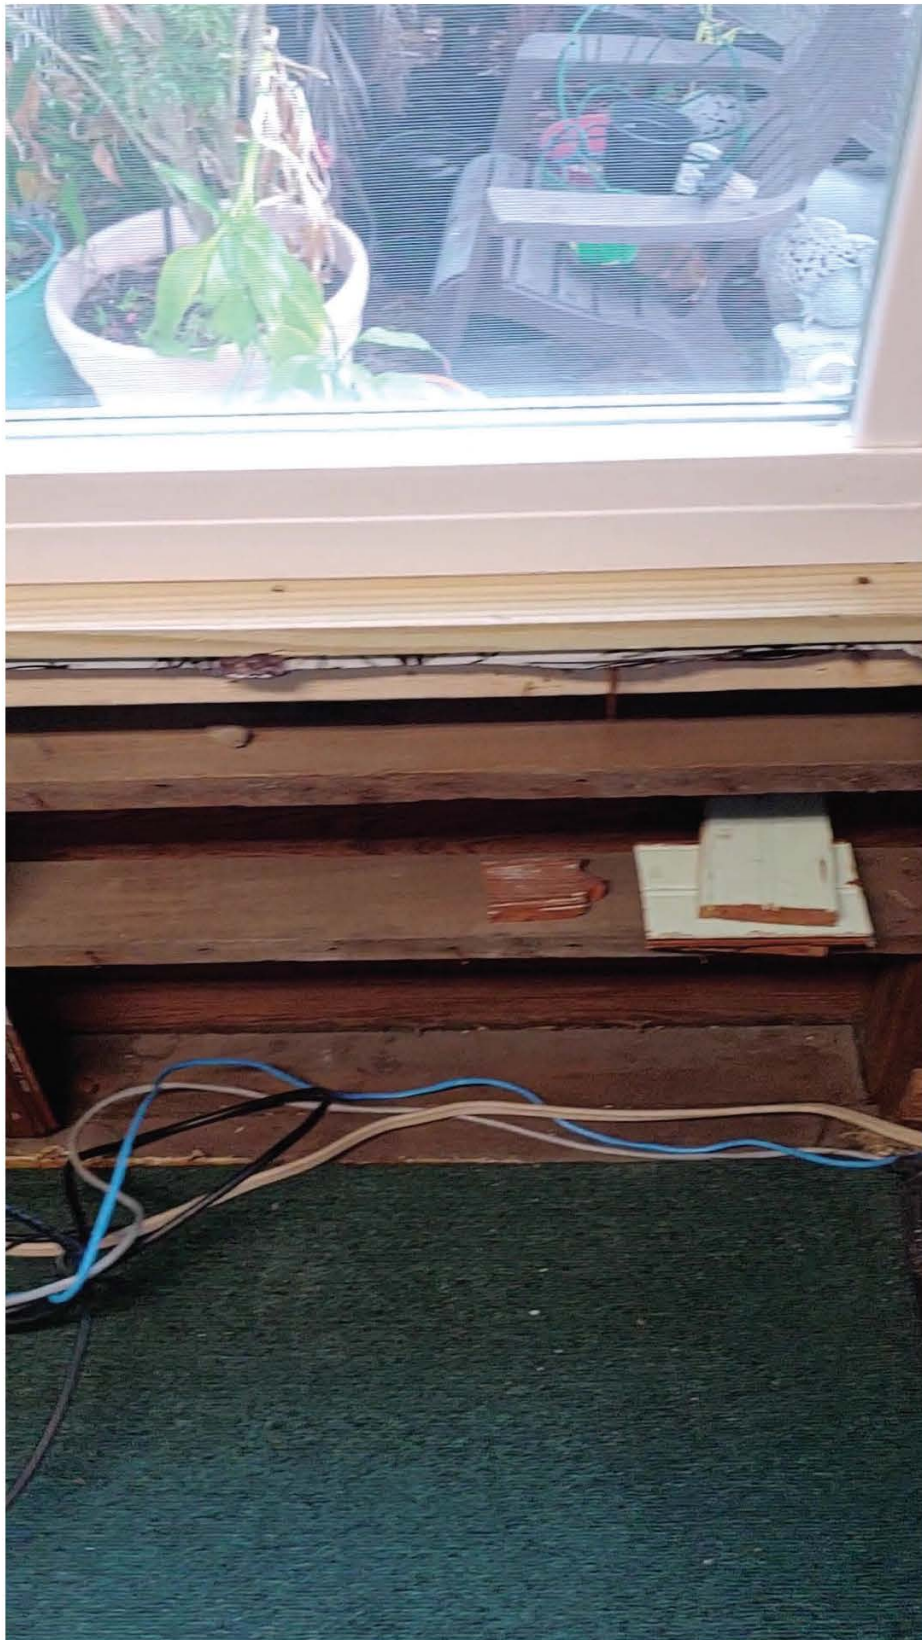
Excessive gaps at left & right, missing shims – See Figure 47  
Sill is not installed/shimmed properly  
Missing Jack Studs – See Figure 48

Figure 47 - Opening #16 - Excessive Gaps, Missing Shims

Figure 48 - Opening #17 - Improper Sill Installation  
- Missing Jack Studs

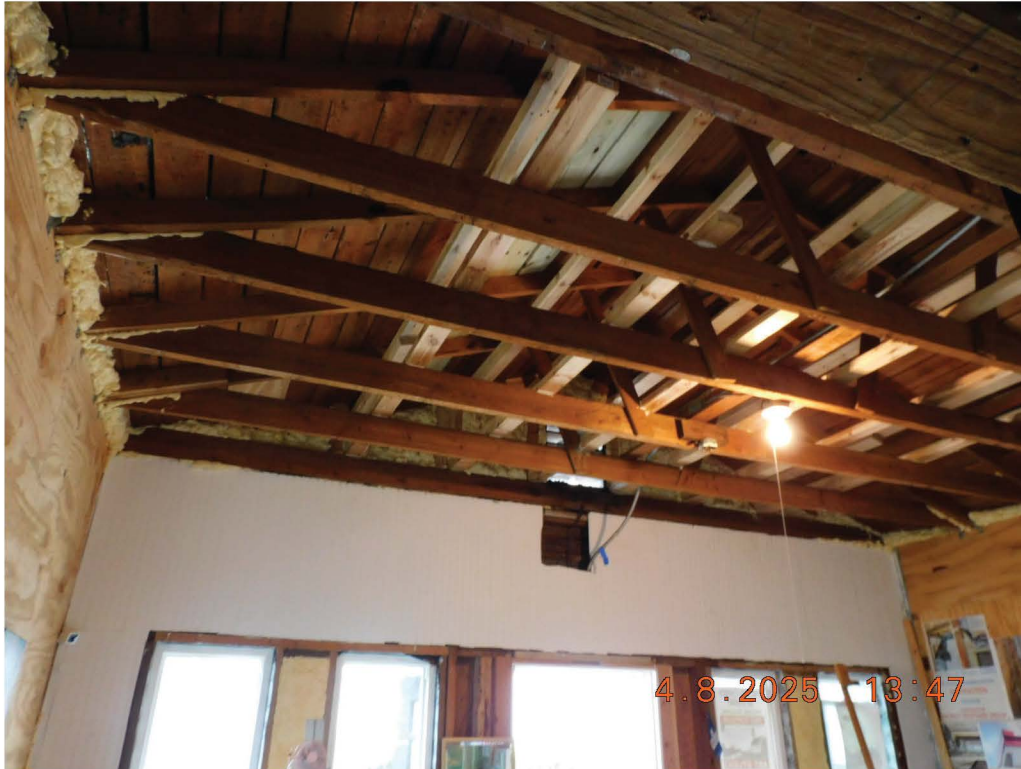
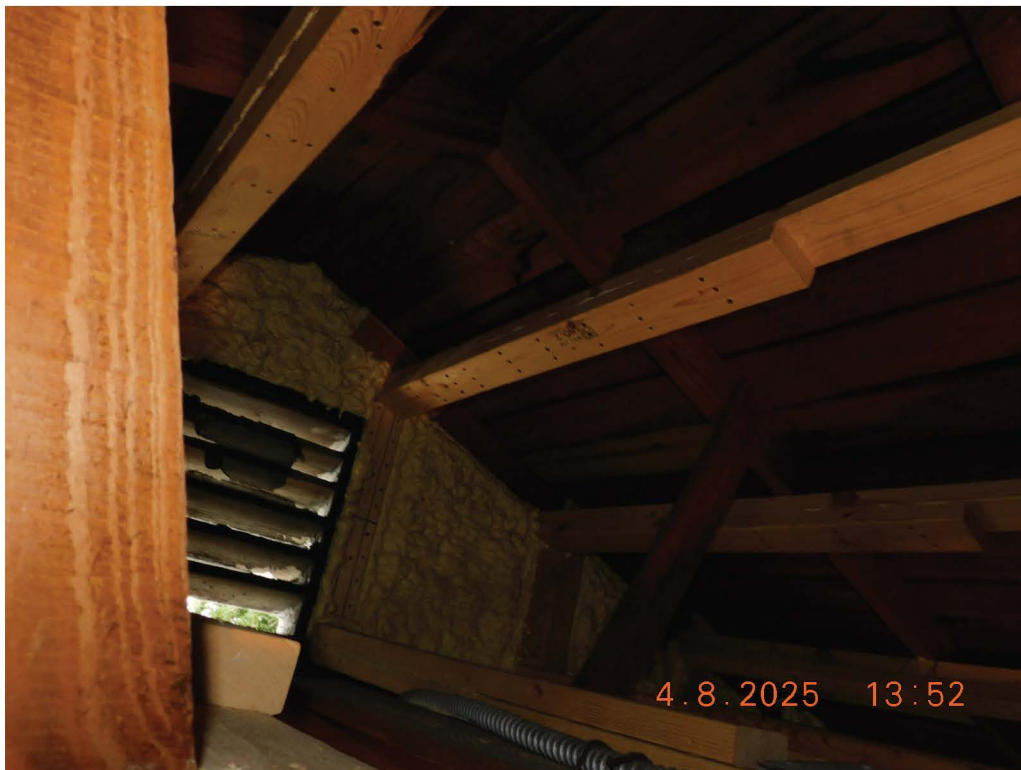
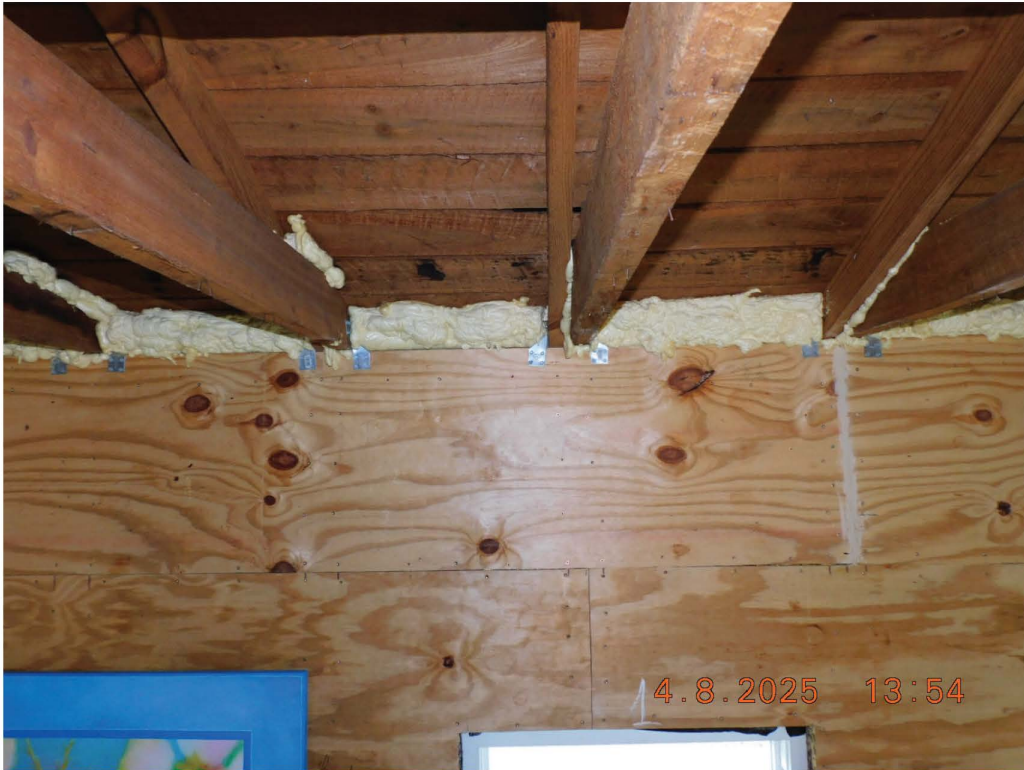
Figure 49 - Added Section at Front - Roof / Ceiling Area

Figure 50 - Added Section at Front - Gable Reinforcement

Figure 51 - Added Section at Front - Clipped Ceiling Joists

Additional gable end bracing should be added to further storm readiness of the building. This report also mentions the need for additional collar bracing and collar ties added where missing or only sporadically used.

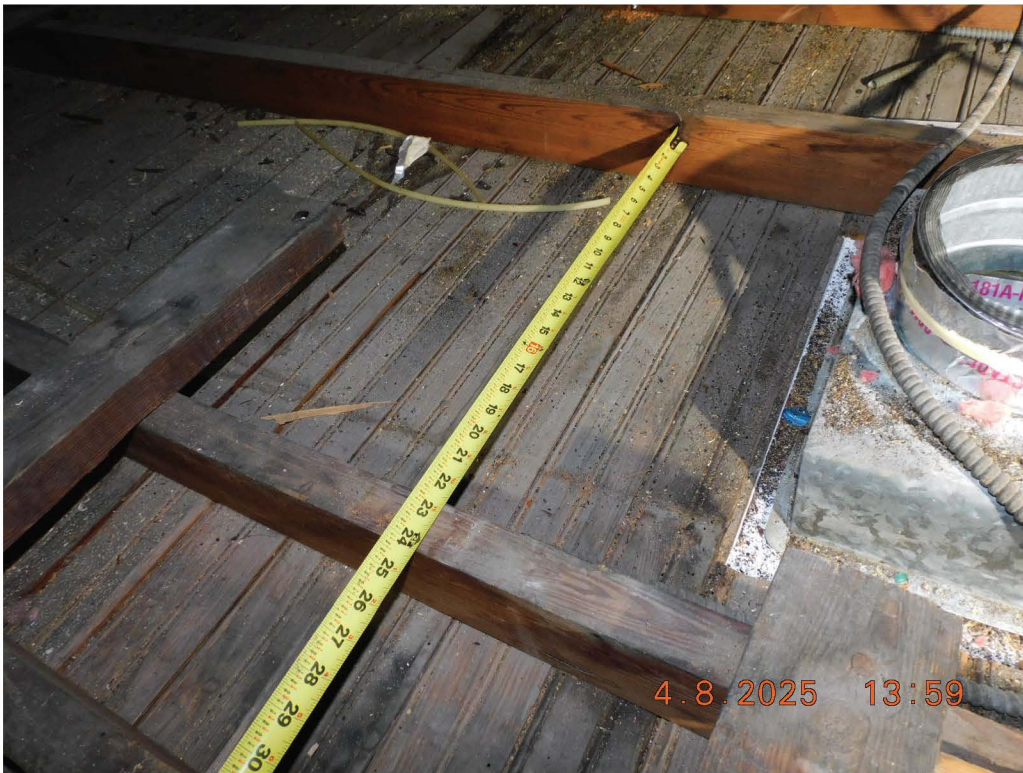
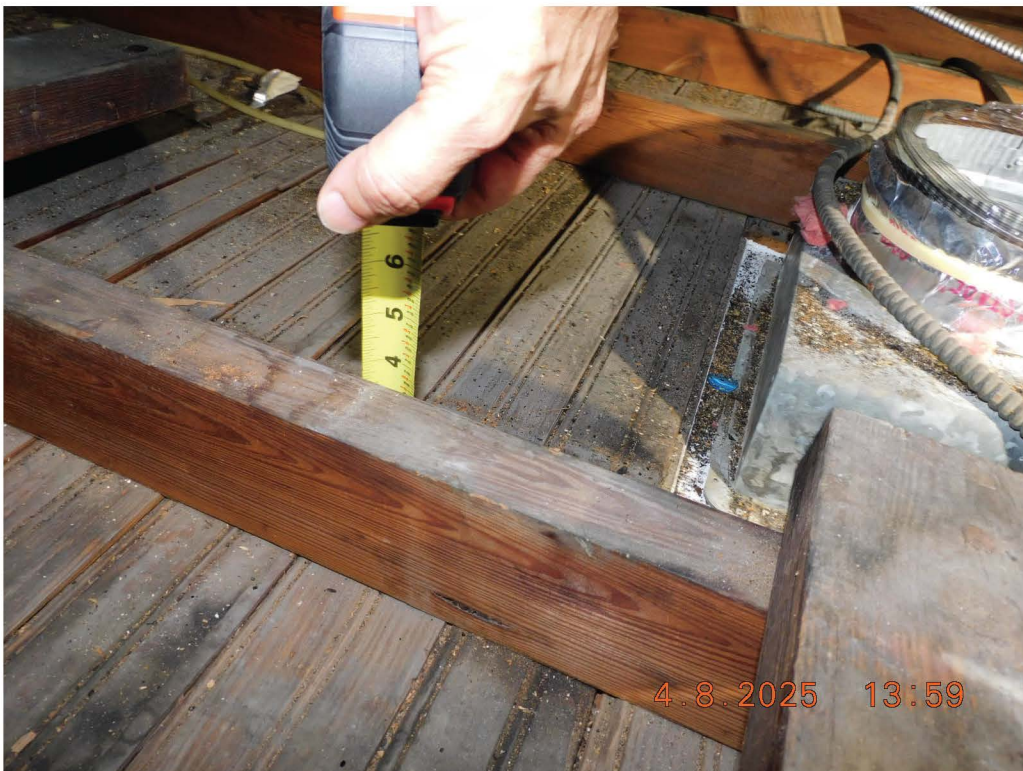
Figure 53 - Ceiling Joist Spacing in Original Section

Figure 54 - Ceiling Joist Size in Original Section

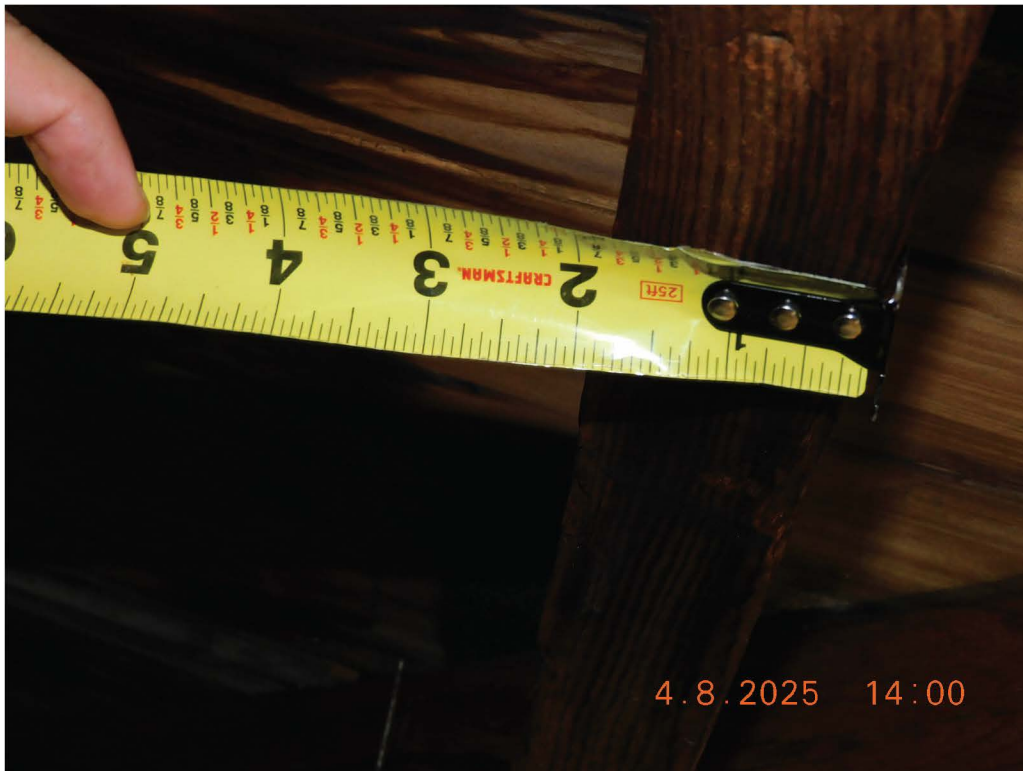
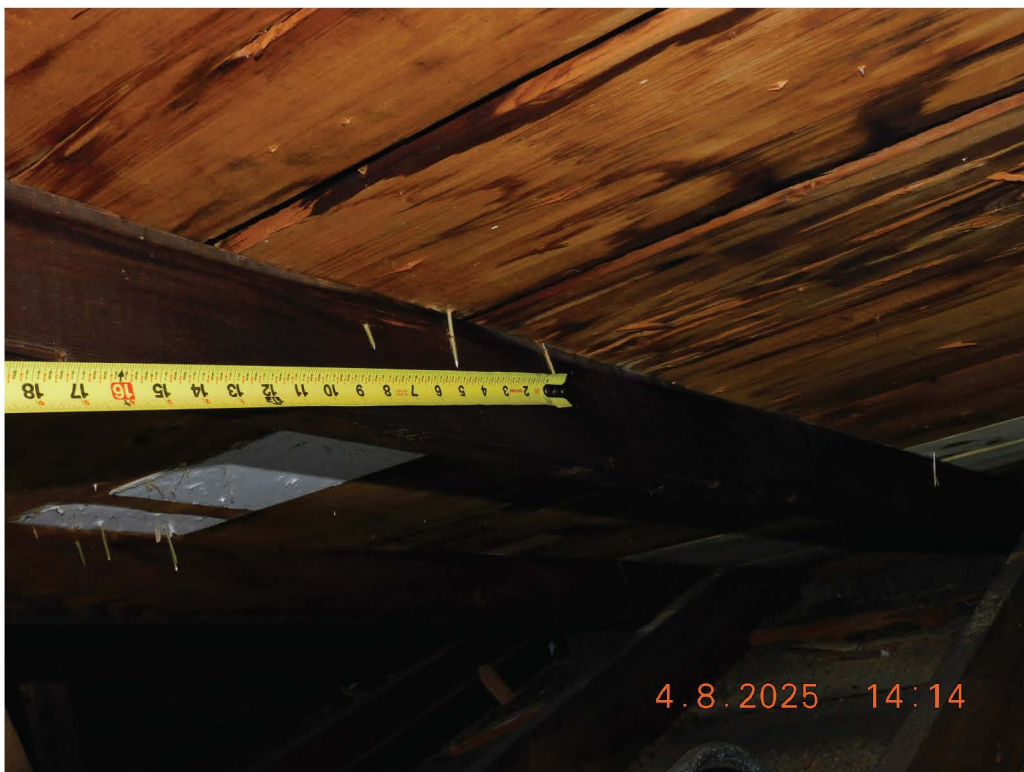
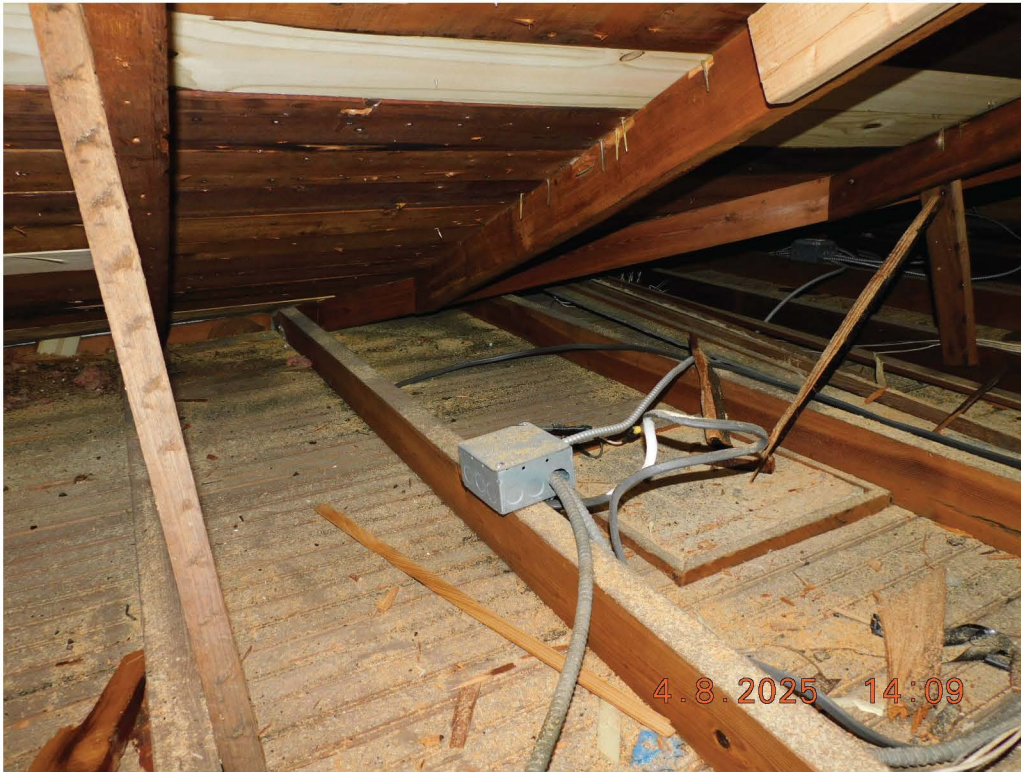
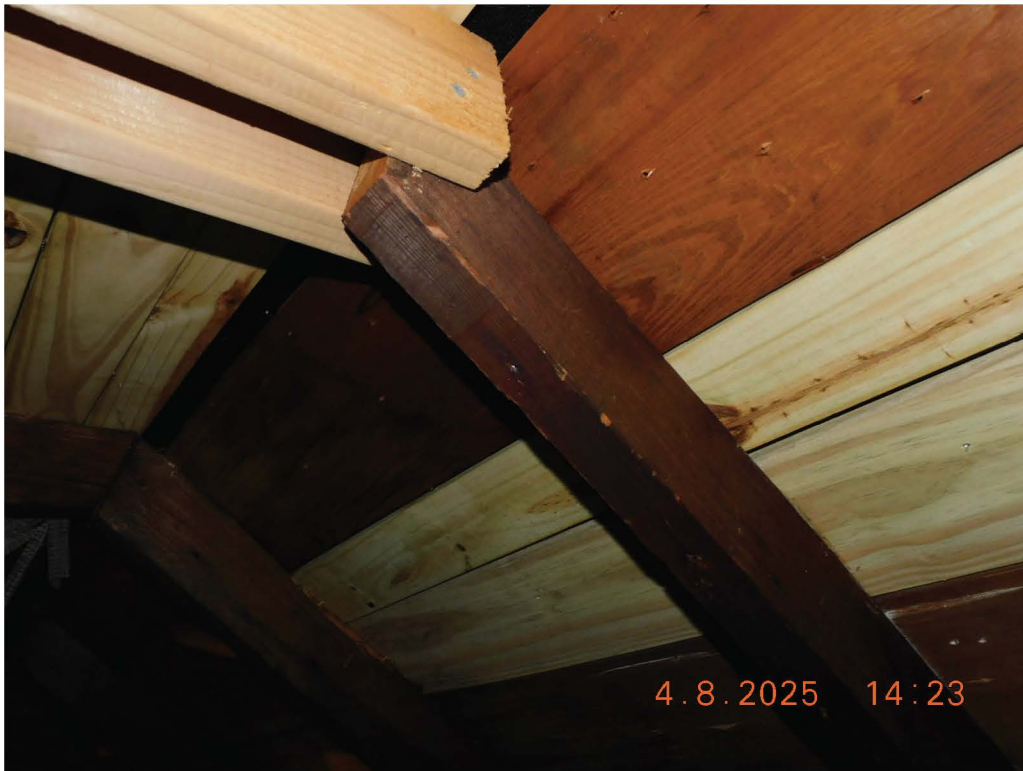
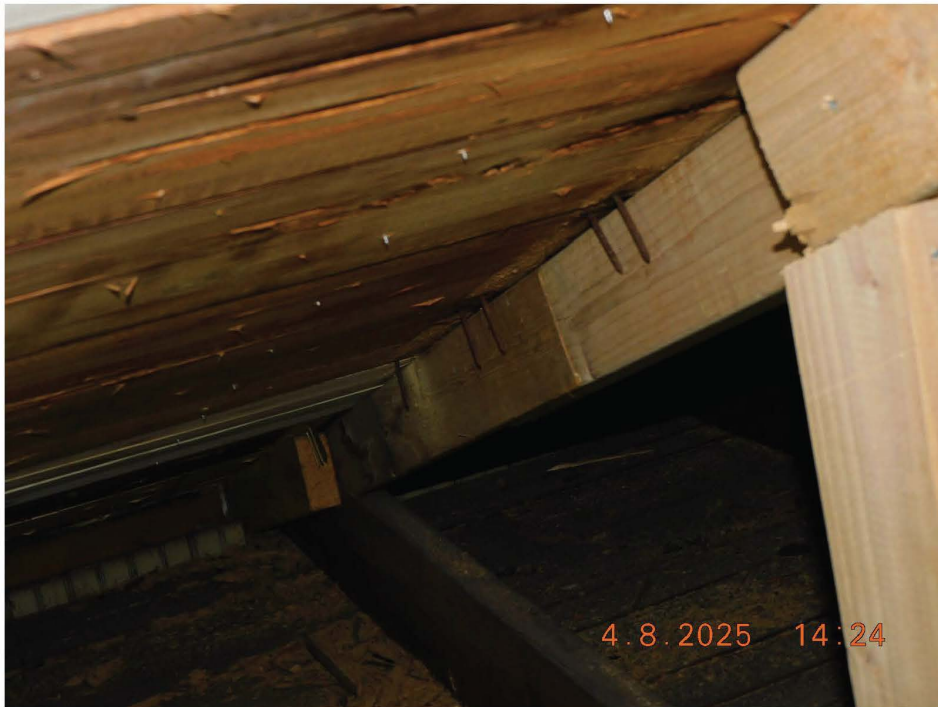
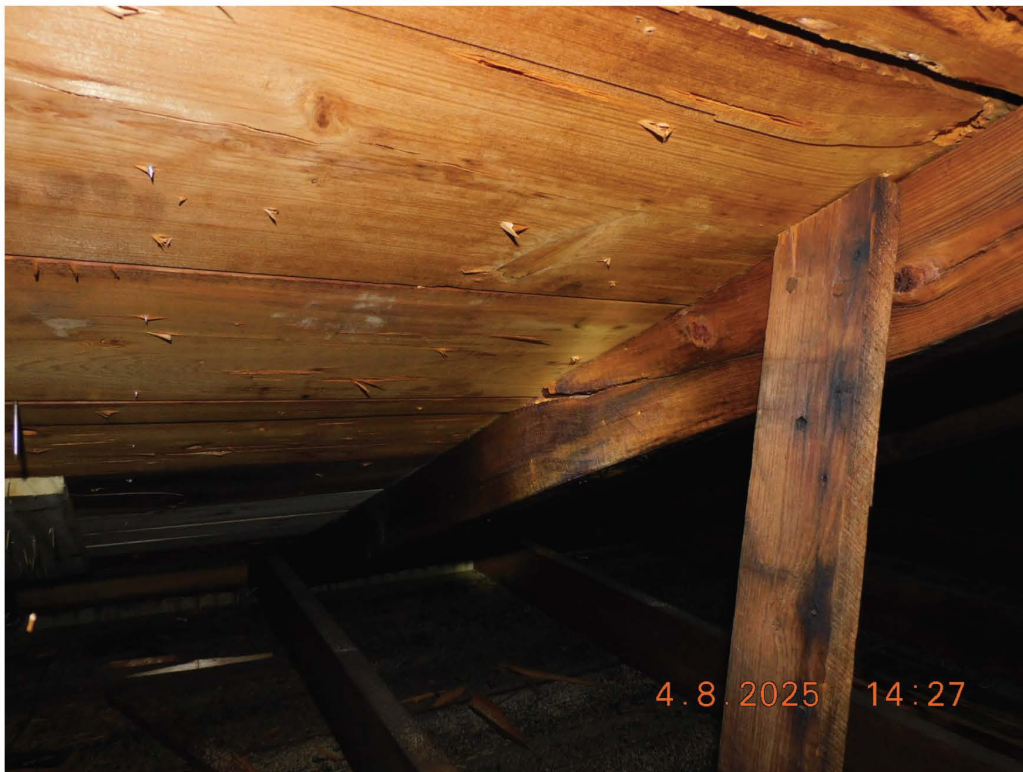
Figures 55 and 56 show a few roof rafters, one measured, the other showing nails that missed their mark. Figure 57 shows a repaired rafter with Roof Sheathing nails that missed their mark. Figure 58 shows an attempt to repair a damaged rafter. Figure 59 shows another attempt to repair a damaged rafter. Figure 60 shows a broken rafter.

Figure 55 - Rafter Size in Original Section

Figure 56 - Nails installed that missed the mark

Figure 57 - Nails installed that missed the mark

Figure 58 - Not a Proper Repair or Installation.

Figure 59 - Not a Proper Repair or Installation.

Figure 60 - Broken Rafter Needs to be Repaired

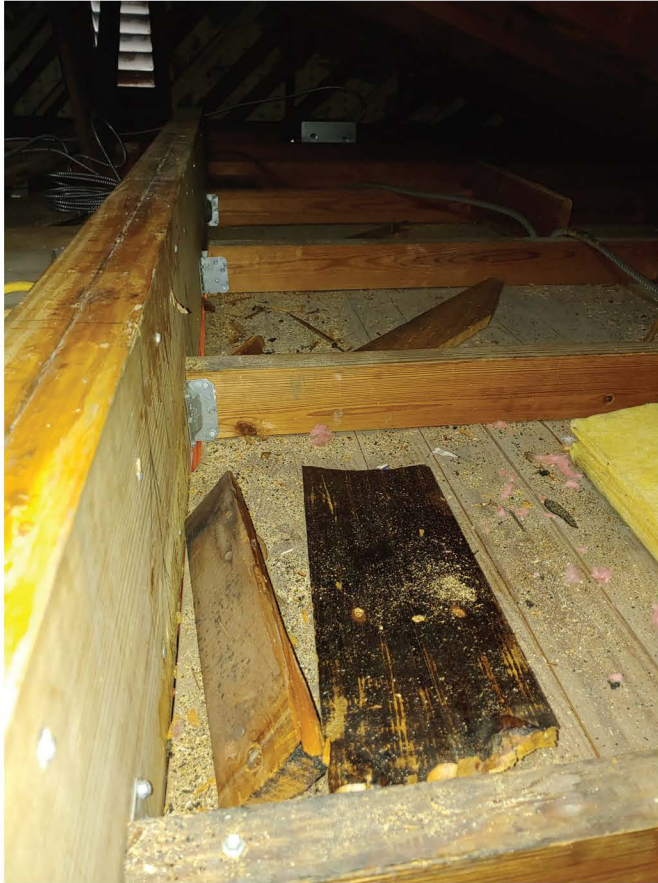
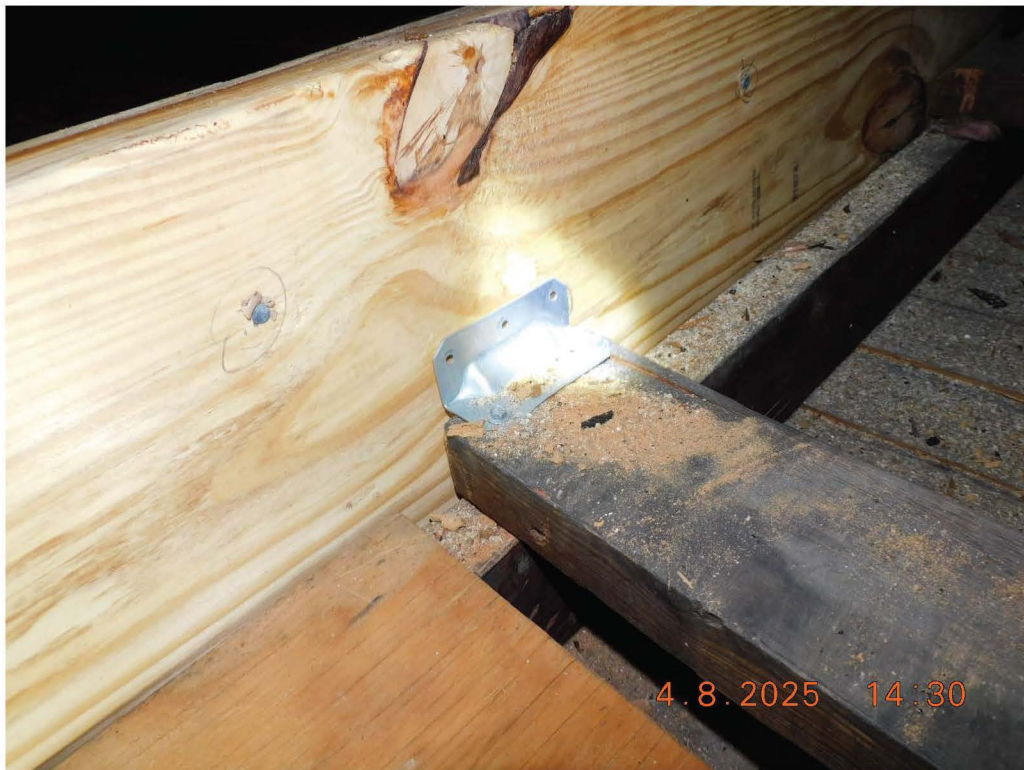
Looking at the 3<sup>rd</sup>, or the cross portion of the building there is a double 2x beam spanning the section. The original beam has been replaced with newer lumber. Figure 61 shows the beam spanning the connection with the newer section to the right side of the picture. Figure 62 shows the left side of the beam with a clip missing its screw. There are other clips that also have issues with missing or screws that are not penetrating the substrate that are not included in this report but are visible.

Figure 61 - Clip is missing screws in new section.

Figure 62 - Clip is missing screws in new section.

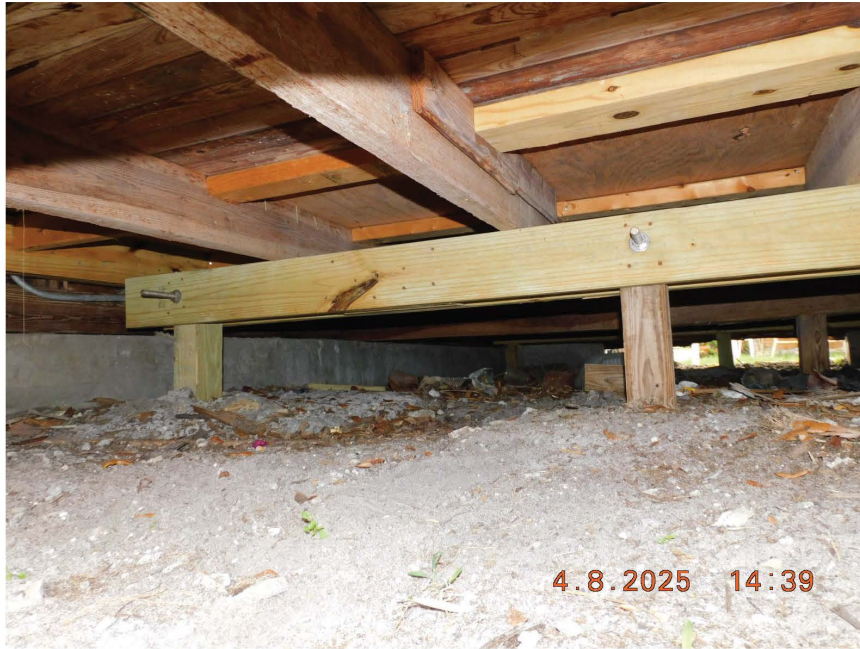
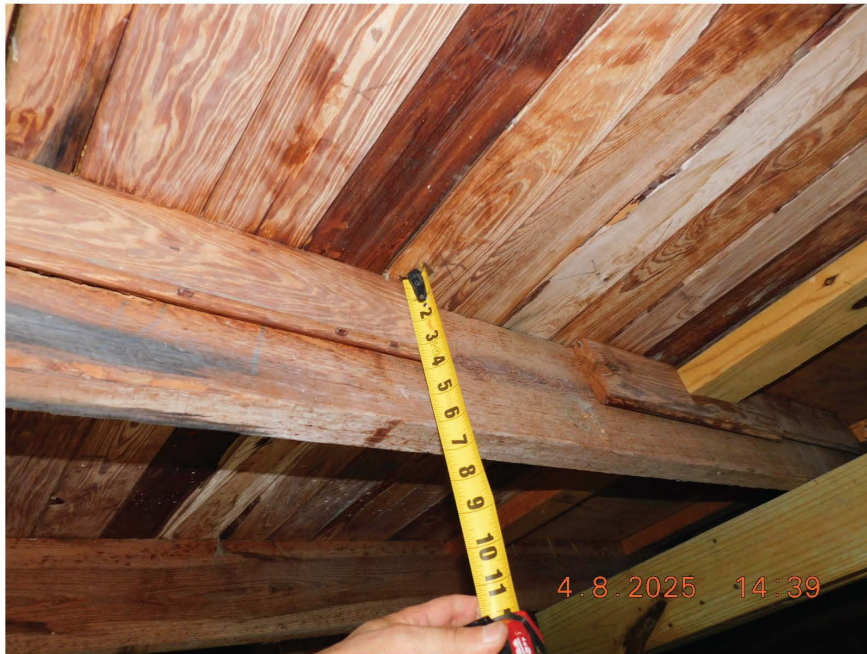
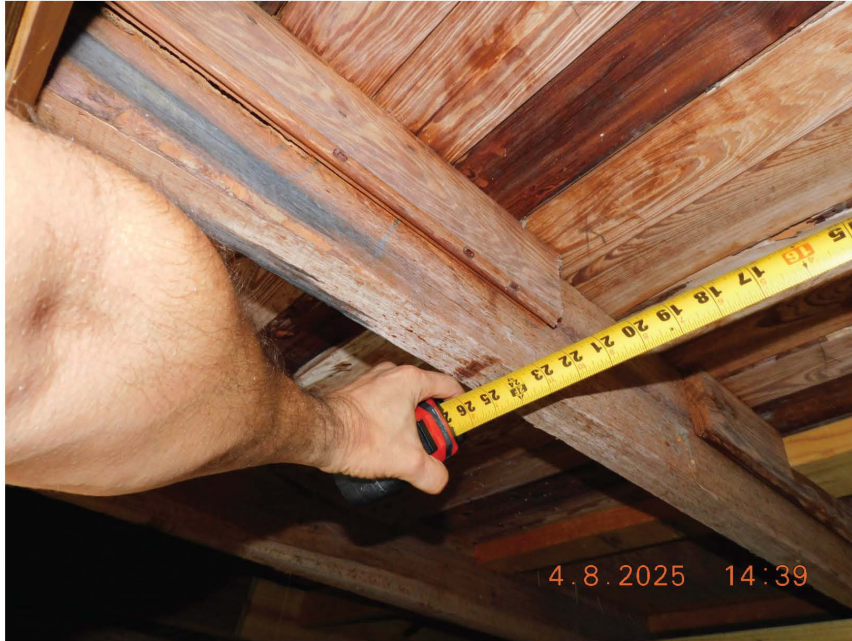
The foundation is also wood framed with concrete piers and pedestals. Figure 63 shows how the original framing has been reinforced. There were no noticeable soft spots or irregularities found in the floor while performing the interior inspection. There is the feeling of the wood framed floor that is typical. Figures 64-66 show measurements of the flooring structural elements and their spans.

Figure 63 - Floor Joist and Foundation

Figure 64 - Floor Joist Measurement

Figure 65 - Floor Joist Measurement

An overall assessment of the foundation is included in this inspection. However not all of the information to evaluate the entire design was gathered during this inspection since the foundation was not the primary concern. Evaluating the floor's 2x6 joists we find that they fail on bending and deflection. Additional evaluation may find that the Girders supporting may have a problem as well. It appears as if some flooring reinforcements were made, additional areas may need to be addressed as well.

Bottom line, there are no specific issues to show and there are no immediate concerns with the Foundation. This report just states that using today's load requirements, given the materials used, there are issues that may need to be further addressed. Similarly, this report did not look specifically at the foundation connections due to time and access issues. We did look for any indications of significant foundation issues and none were found.

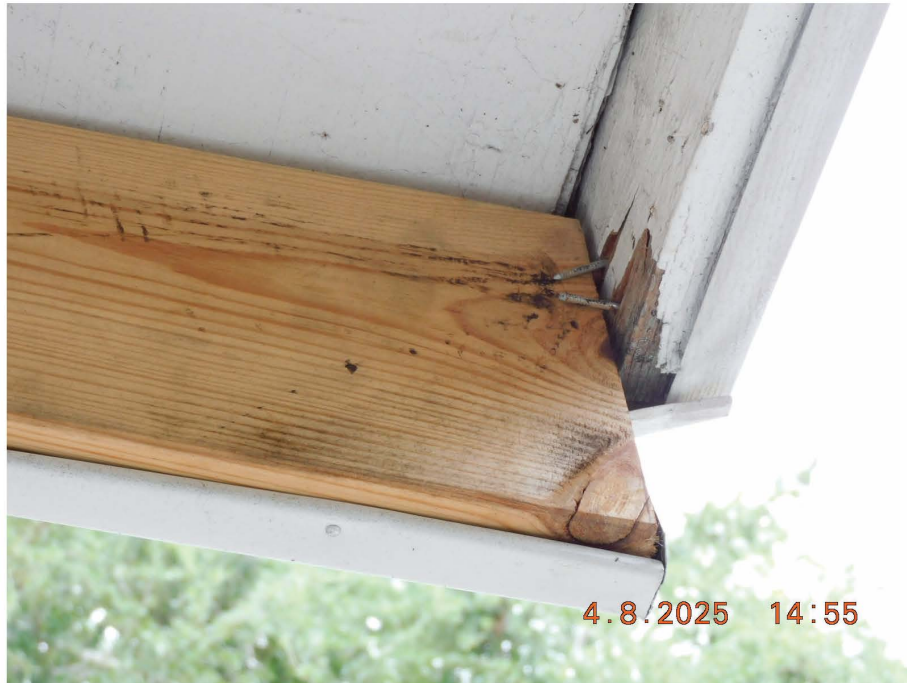
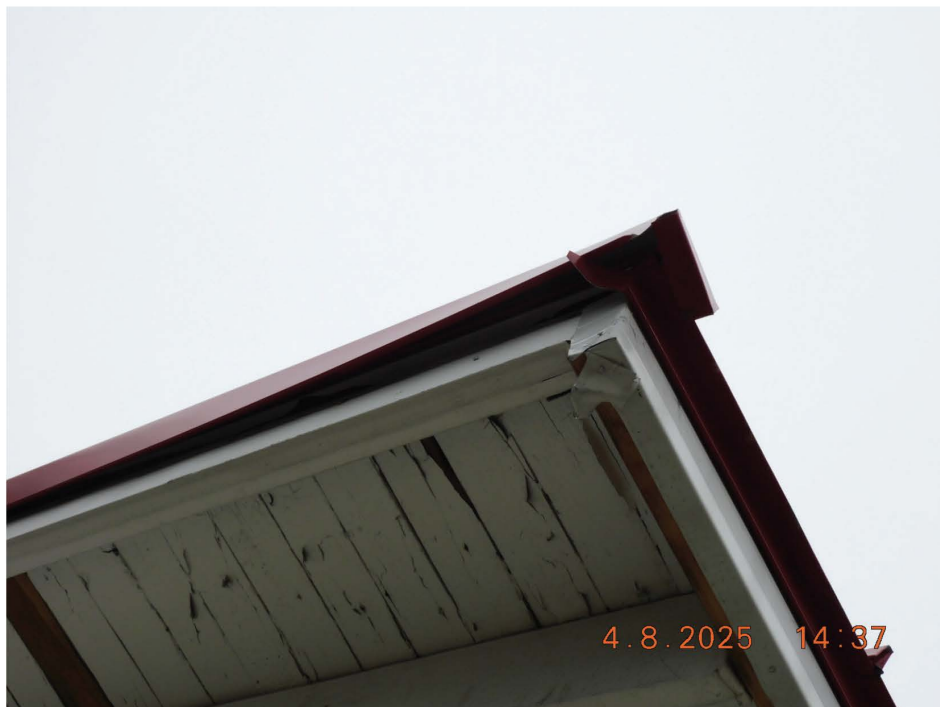
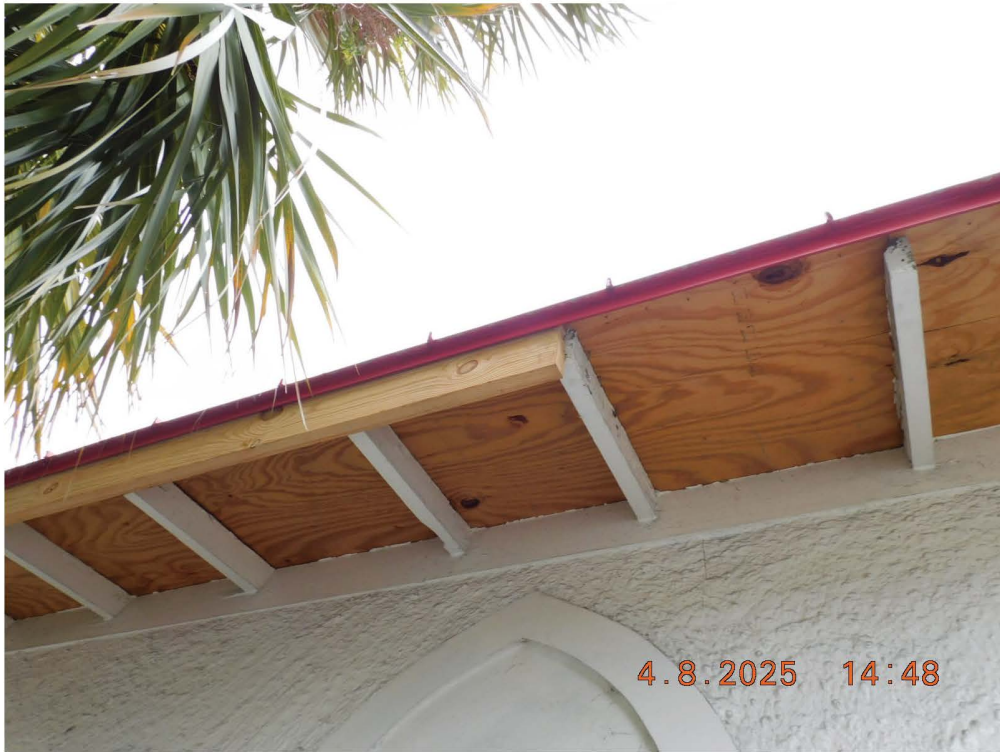
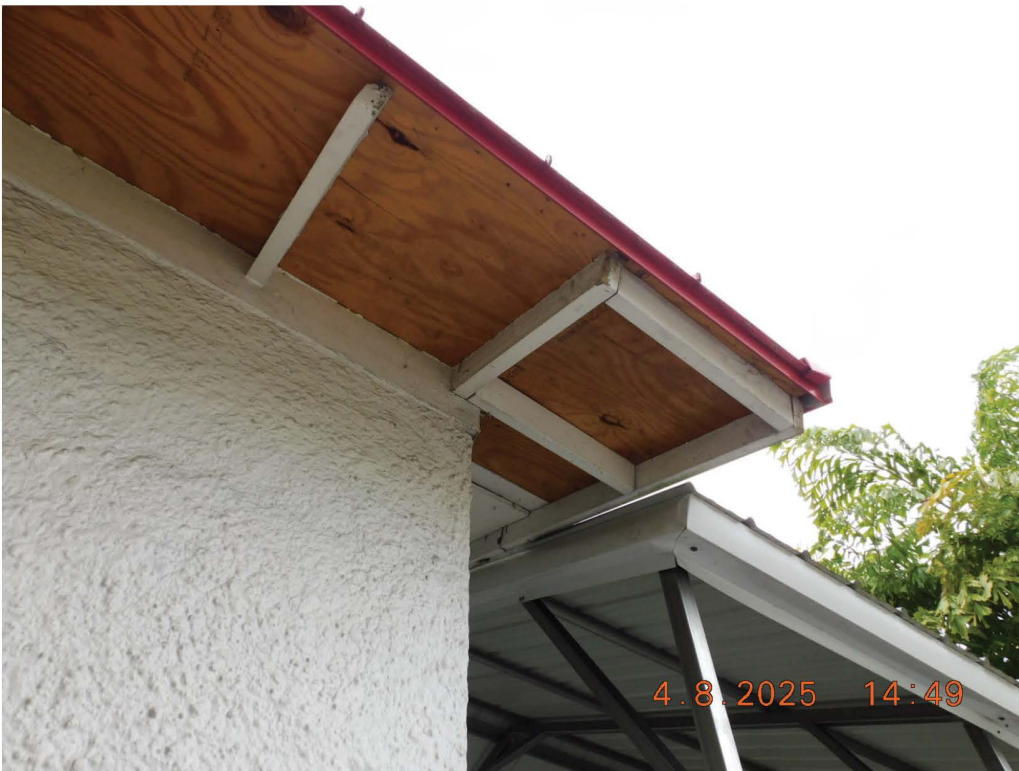
Figures 67 & 68 show the front fascia that was previously mentioned as a cosmetic issue. Looking more closely, the fascia has been improperly installed. In fact, in pictures 69 & 70 an entire section of the fascia fell off the building during a relatively severe rainstorm. And in the Picture of the front of the building, on the left-hand side of the stairs, there is a piece of the cladding that fell off the front of the building laying on the ground.

Additionally in Figures 71 & 72, the new modern plywood roof sheathing is showing. The missing fascia and cladding are clearly shown. The fascia was installed using nails into the ends of the rafters. Using nails in this manner is not acceptable, screws are required.

Figure 67 - Improper Fascia installation.

Figure 68 - Improper Fascia installation.

Figure 69 - Improper Fascia and Roofing Installation

Figure 70- Improper Fascia and Roofing Installation

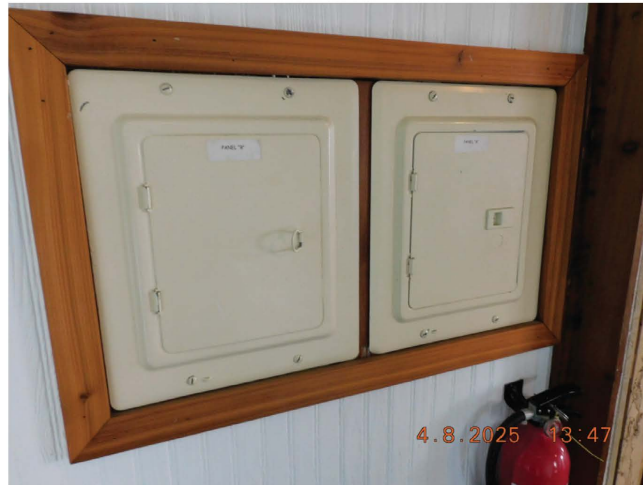
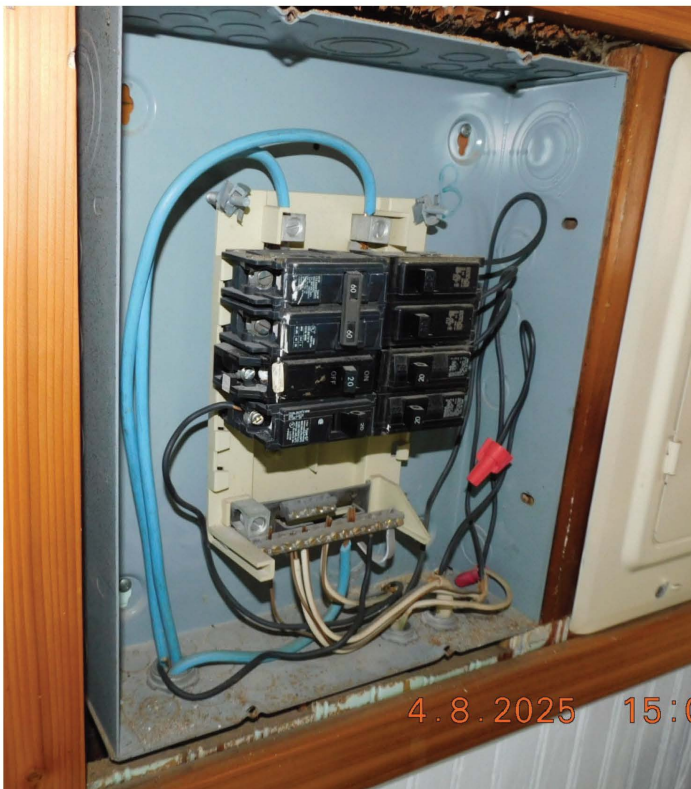
Moving on to the Electrical System, we opened every panel that we found. There were three (3) panels inside and (3) outside. Figure 71 shows Panels A & B. We checked the connections with the breaker and measured the incoming Feeds. Not everything we looked at is shown in this report as we are trying to limit the number of pictures. Figures 73 & 74 show two (2) of the outdoor panels. There are no issues reported with the electrical system. There is a recommendation, but no life safety issues were discovered or reported.

Figure 71 - Interior Electrical Panels

Figure 72 - Interior Electrical Panels A & B, Feeder Size Verification.

The only comment just for documentation purposes, there are a few cloth insulated wires found in the attic space and assumed to be within the walls. The Florida Building Code does not require that these be replaced so long as they are in good condition, are properly installed, and were compliant with the code effective at the time of installation. Again, these cloth insulated wires are mentioned in this report for documentation purposes. No visible issues with these wires were found during this inspection. Many of the connections are not readily accessible.

To ensure compliance and safety, have a licensed electrician evaluate the wiring's condition and consult with your local building department for any specific regulations. If insurance is a concern, you may need to replace some of the wiring to meet insurer standards, even if the FBC allows it to remain.
