### Inspection Report – Structural & Electrical

May 13, 2025

Regarding: Historical Renovation of 1895 Church  
311 SW 3rd St.  
Stuart, FL 34994

Date of Inspection: 04/04/25

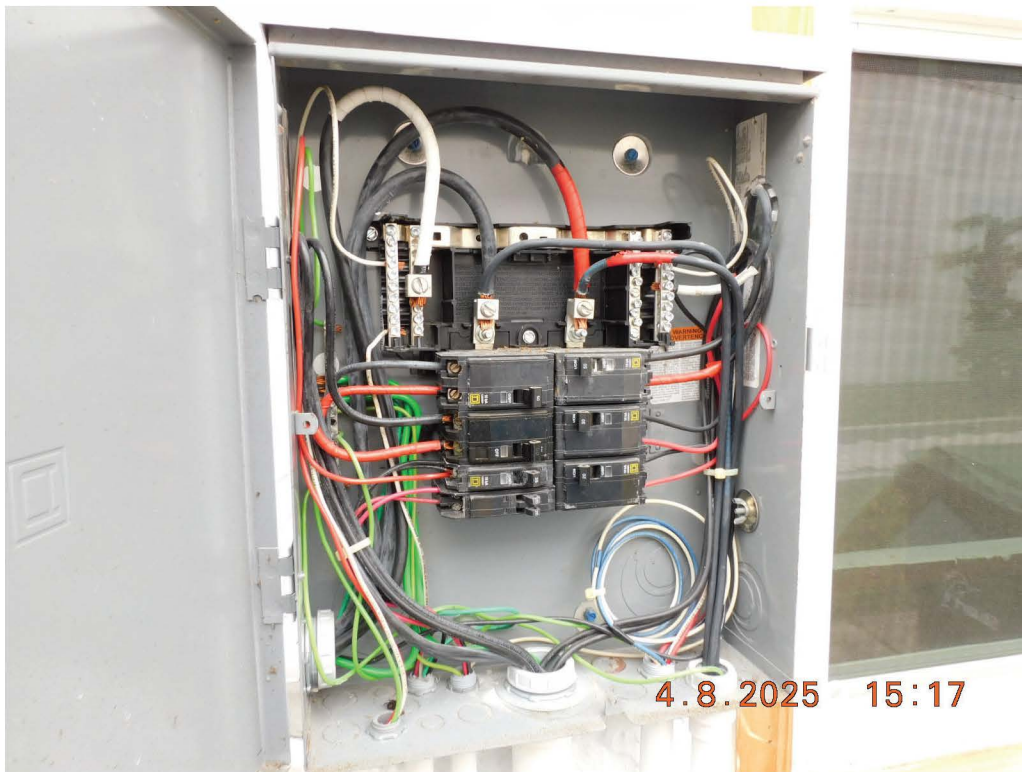
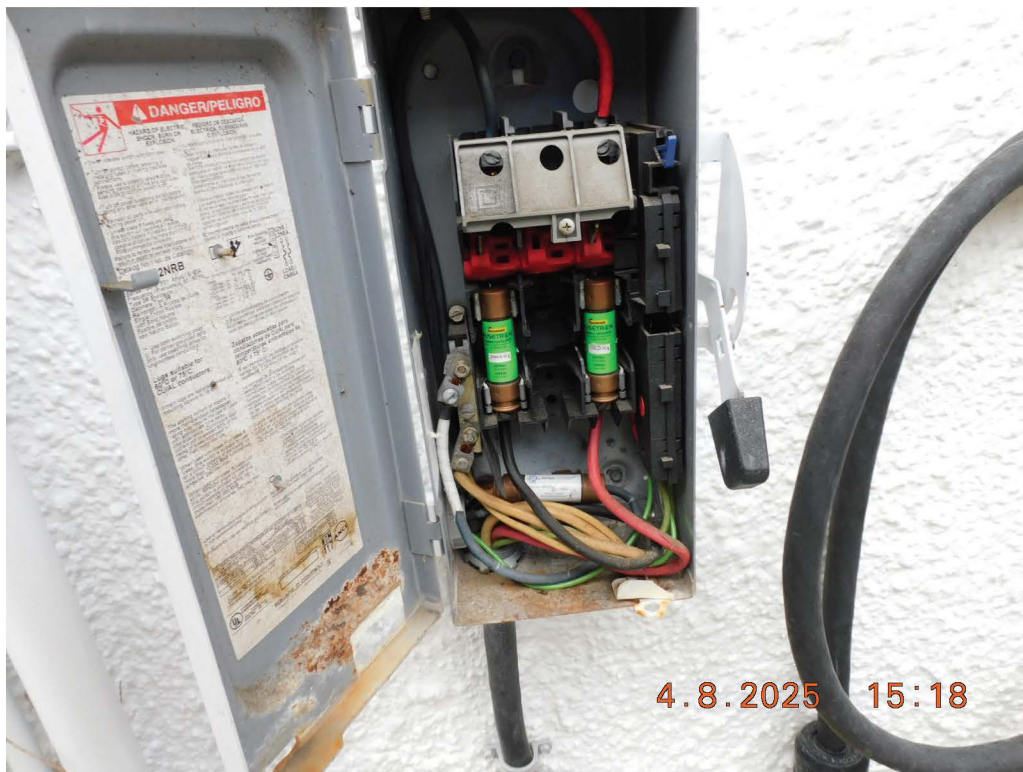
Figure 73 - Exterior Electrical Panel

Figure 74 - Exterior Electrical Panel - Main

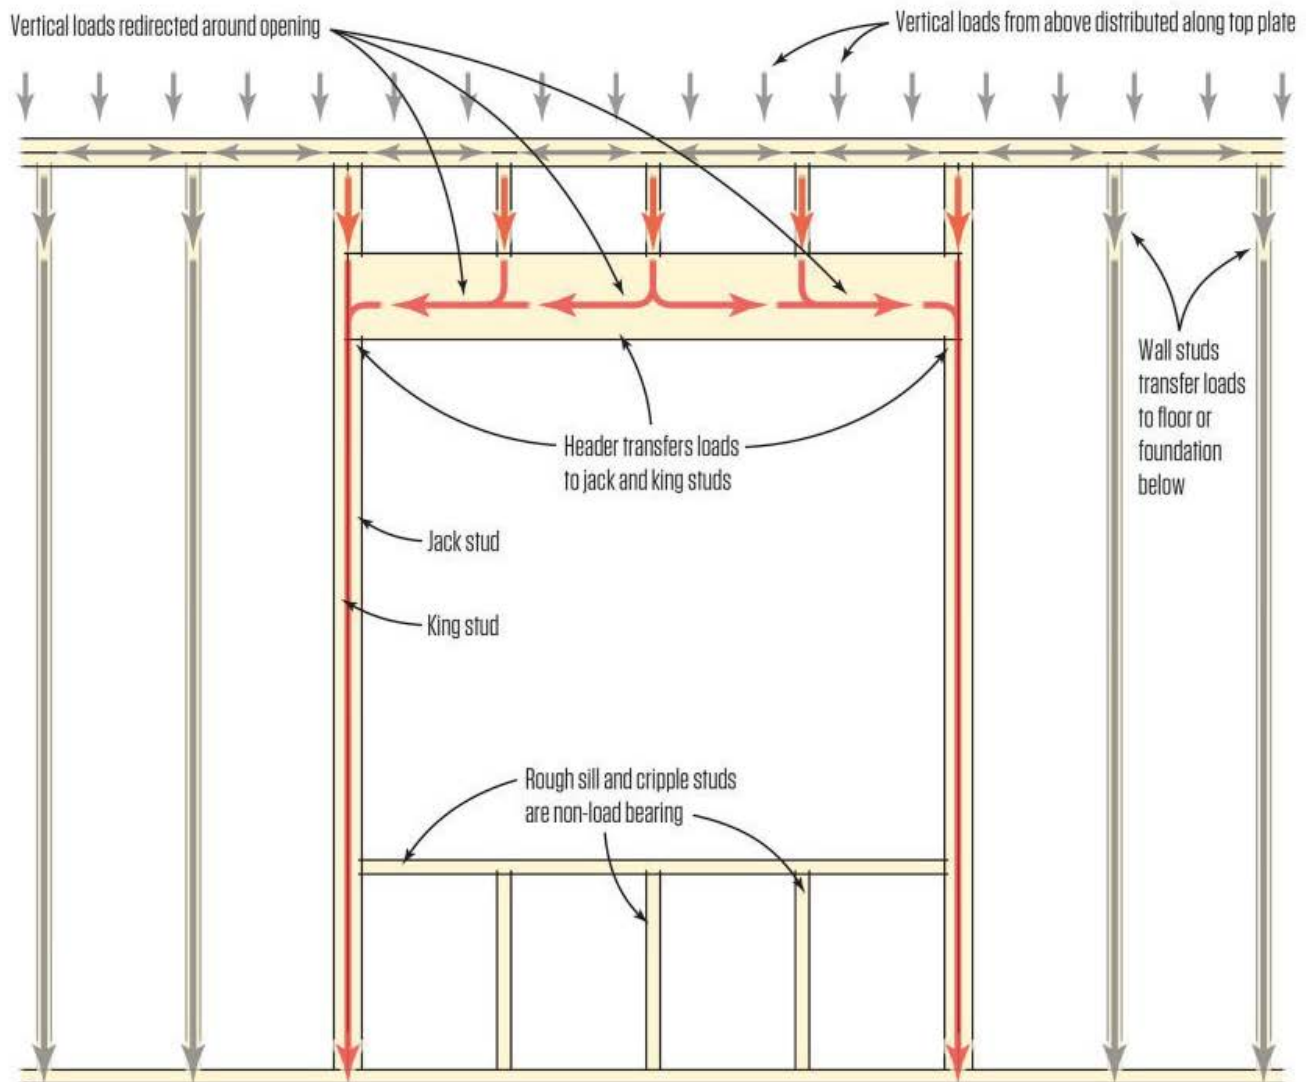
As mentioned previously, wood framed construction was based on ensuring a continuous load path from the source of the load all the way to the foundation. Please see Figure 75 for a typical modern window opening load path diagram. The diagram illustrates how the load from above is transferred to other load bearing elements all the way from the top of the building to the ground. Keeping this principle in mind, when looking at a historical building and knowing that in the past the Sill was a load bearing member calls into play those 1x4 modern sills installed improperly.

Figure 75 - Typical Load Path Diagram

When something interferes or breaks the specific original load path, the affected load will find a new path. This new path may not be one that is favorable to the longevity of the building. This is why what may be seen as a simple piece of wood is actually more important than it appears. Normally a Trimmer stud would perform this task. In this building some of those Trimmer studs have been removed or cut. In all cases where the windows were replaced, specifically the concerning the bucking and shim work, is considered poor workmanship bordering on amateurish installation. Harsh and true. This alone warrants complete replacement.
